# HEMPHILL DIVERSION STRUCTURE AND FISH PASSAGE ASSESSMENT

## FINAL REPORT

**Nevada Irrigation District**  
Grass Valley, California

**Northwest Hydraulic Consultants Inc.**  
Sacramento, California

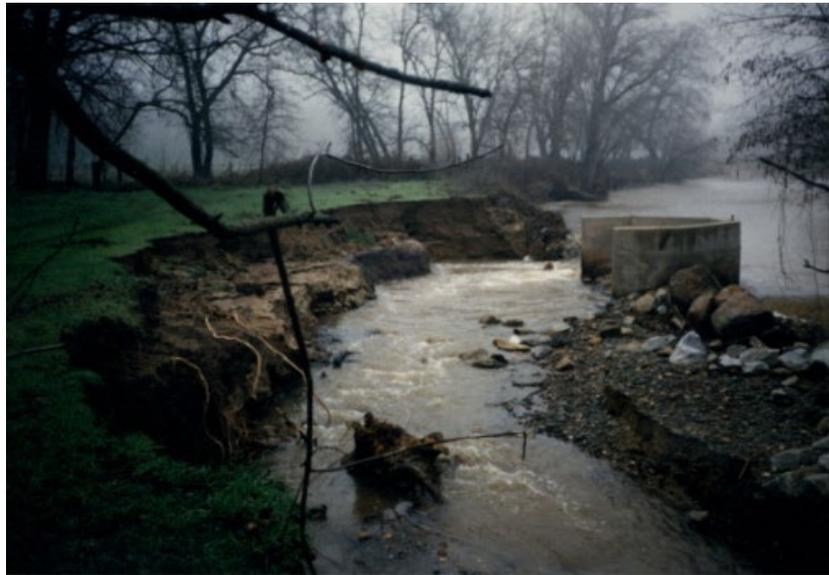
Large floods in 1997, 2006, and 2017 caused significant erosion and scouring around and under the dam. In 1997, the flow flanked the dam and eroded the north and south banks. As such, both banks and the dam's apron are heavily armored with grouted riprap. Photos of the damage, provided by NID, confirmed that the erosion was extensive (Figure 1-2). NID rectified the issue by fortifying the northern bank and dam apron with grouted riprap (Figure 1-3). An aerial view of the Hemphill Dam shows that the dam is located on a mild meander bend in the Auburn Ravine, with the northern side of the dam on the outside of the bend. Because of this, NHC recognizes that the north side of the dam remains more susceptible to flanking and erosion than the south bank of the dam.

**Figure 1-2. Extensive erosion on the north bank caused by high flows in 1997. Photo provided by NID.**

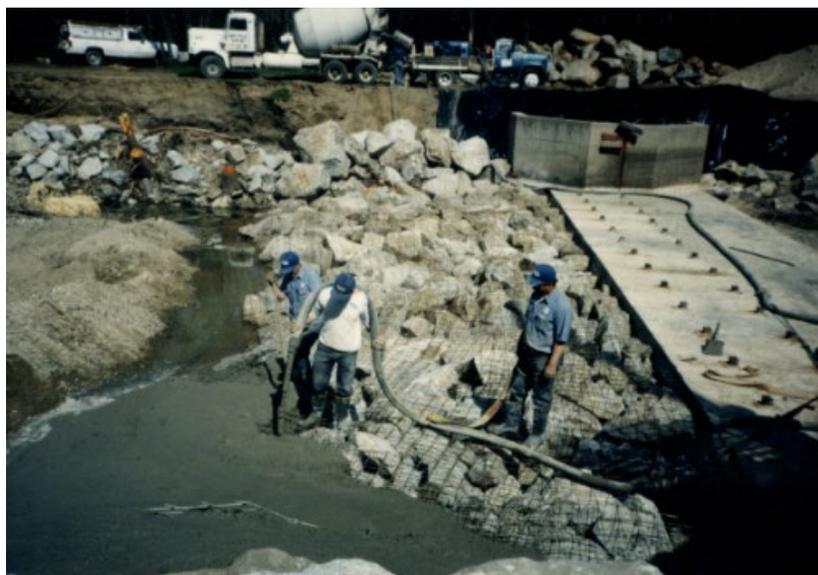
**Figure 1-3. Fortifying the banks and dam apron with grouted riprap following the 1997 flood. Photo provided by NID.**

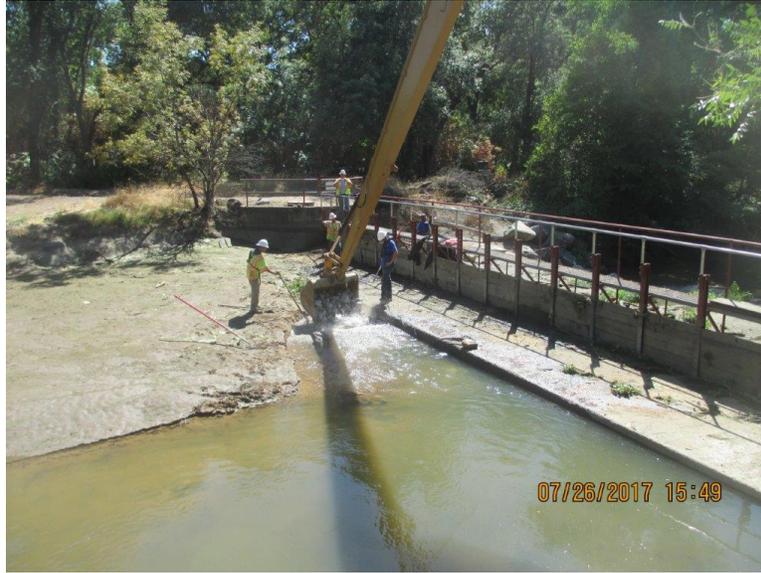
the concrete plug and the bottom of the original dam foundation, indicating that the dam’s foundation is compromised. Finally, NID had to complete an emergency repair due to water going around and under the dam near the right bank, likely following high winter flows. The 2017 repair consisted of placing erosion resistant fabric and rip rap upstream of the dam (Figure 1-4).

**Figure 1-4. Placing riprap in scour hole upstream of dam following winter 2017 floods. Photo provided by NID**

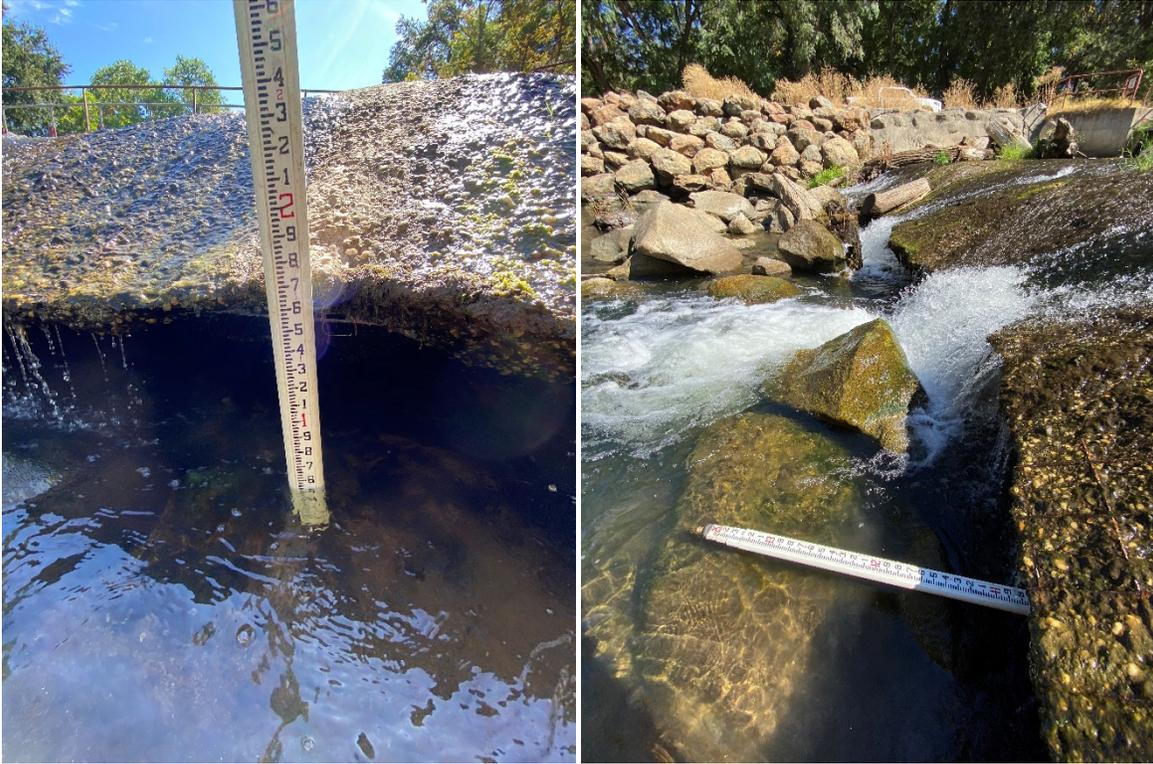
During the September 22, 2020 site visit, we observed that the downstream edge of the dam's concrete apron constructed as part of the 1997 repair (Figure 1-3) was perched approximately 1.5 feet above the downstream channel, and the scour hole extended approximately 11 feet under the concrete apron (Figure 2-1 and Figure 2-2). Some of the wire mesh had become exposed within the shotcrete on top of the apron. It was also evident that there was seepage flow under the dam. Based on field observations, and Doug's recounting of the attempts to plug the dam with concrete, it is likely that another large flood event may further compromise the dam or cause it to fail entirely, given that its foundation is already compromised. Large woody debris had also accumulated on the dam's apron (Figure 2-3). NID noted that woody debris was common at this site, which may limit the feasibility of some in-channel fish passage designs.<sup>2</sup>

**Figure 2-1. Erosion under the dam apron as of September 22, 2020. The apron was constructed after the 1997 flood, as shown in Figure 1-3. The photo on the left shows the apron perched approximately 1.5 feet above the downstream channel bed. The photo on the right shows that the scour hole extends approximately 11 feet under the dam; the wire mesh, that was originally encased in the shotcrete is becoming exposed on the apron's surface.**

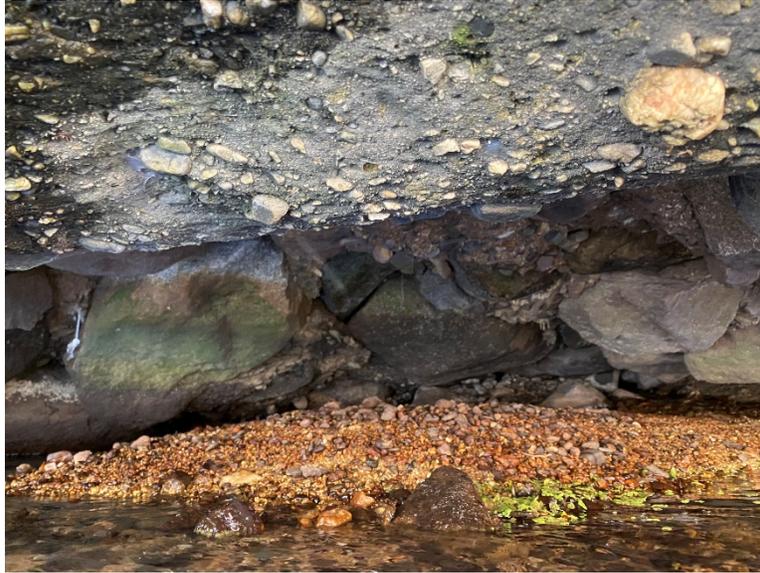
**Figure 2-2. Looking under the dam apron – the foundation has eroded under the concrete encased boulders.**

Based on our review of existing documents, photographs, bathymetric survey data, and from the site visit on September 22, 2020, it is evident that the existing dam's foundation has become significantly compromised due to three major flood events, and through ongoing erosion processes. Only the concrete sill (Figure 1-1) is composed of structural concrete, and this structural concrete is relatively thin and sitting on a foundation of unreinforced concrete grout with likely voids (Section 2.1). Much of the downstream apron is composed of grouted riprap which has been undercut by downstream erosion and the 2006 and 2017 damage. Due to the previous performance, lack of structural concrete, and changes in site conditions since implementation of the original design, it is assumed cutting into any of the dam structure may have adverse impacts to its overall structural stability.

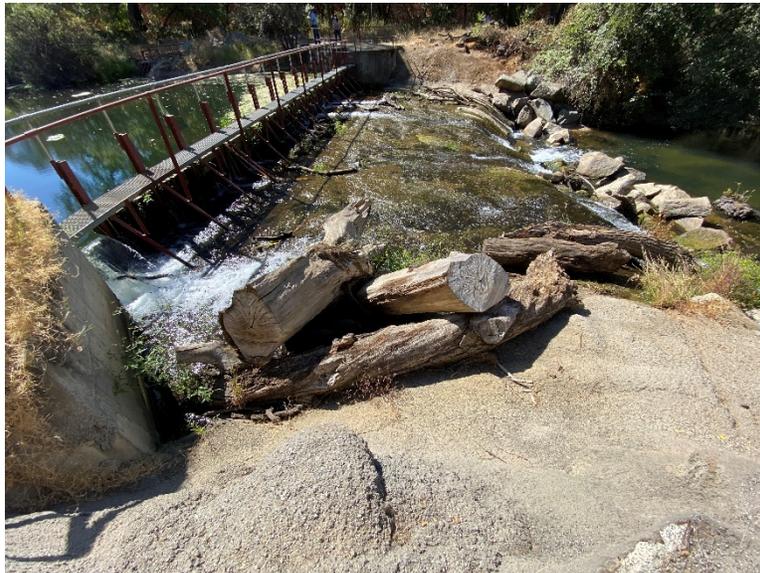
**Figure 2-3. Large woody debris accumulated on the banks and the dam's apron**

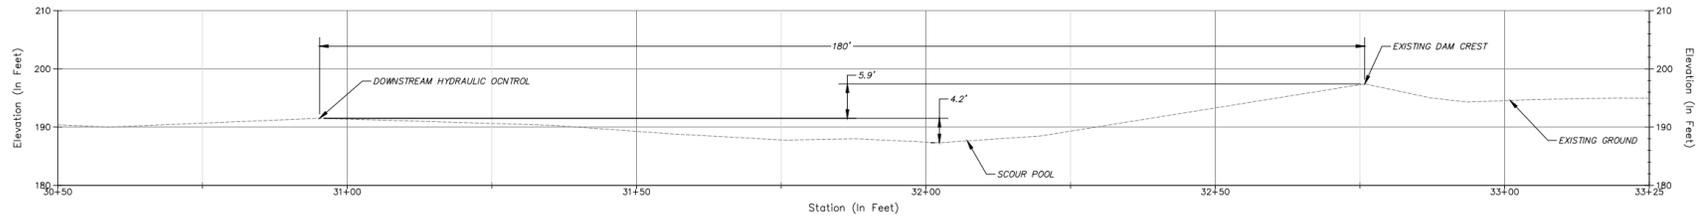
downstream caused by flow plunging over the dam also increases. Under existing conditions, the dam crest is 10.1 feet above the channel invert immediately downstream of the dam. The channel invert rises about 4.2 feet from the low point of the scour hole to the downstream channel (Figure 3-1). The hydraulic drop over the dam appears to be about 6 feet. Incorporating the hydraulic control point into a nature-like fishway (discussed in Alternatives 1 and 2) can significantly decrease the amount of elevation fish will have to overcome to navigate past Hemphill diversion.

**Figure 3-1. Channel profile downstream of the Hemphill Dam showing a scour pool and a hydraulic control point. There is a 5.9 ft elevation difference between the existing dam crest and the hydraulic control 180 ft downstream. There is a 10.1 ft elevation difference between the dam crest and the scour pool immediately downstream of the dam.**
