Staff Report

SUBJECT: Lower Cascade Canal and Upper Grass Valley Canal Tree Health, Canopy Cover and Pond Monitoring Report – Year 10 (Project No. 6593-2)

BANNER CASCADE PIPELINE PROJECT TREE HEALTH, CANOPY COVER, AND POND MONITORING REPORT – YEAR 10

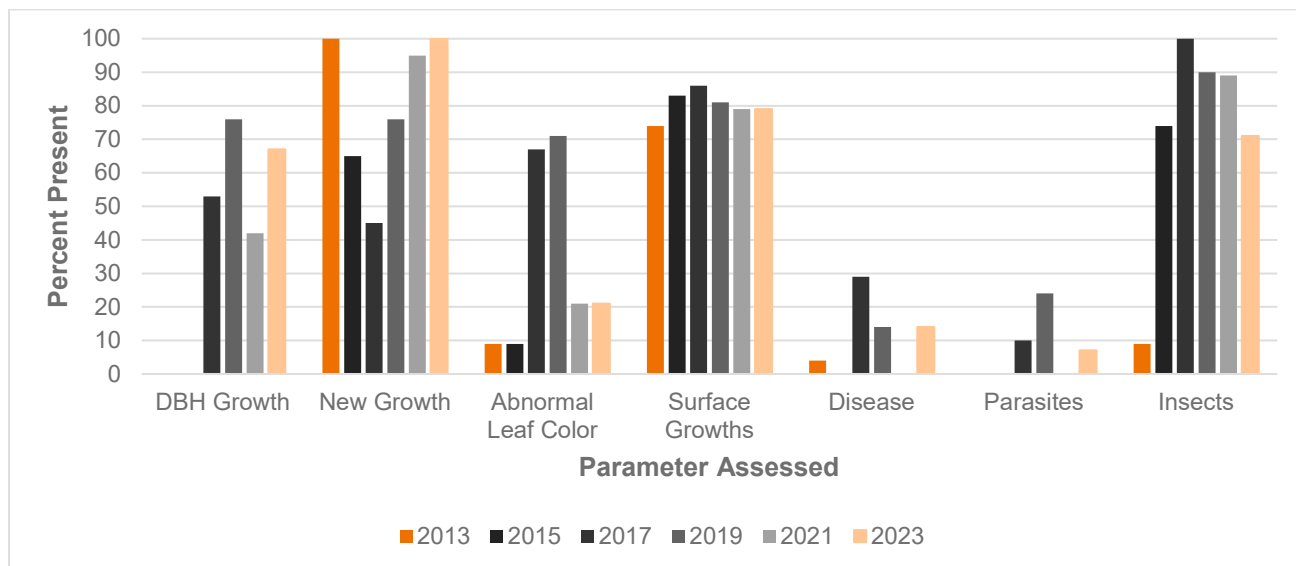
Graph 4-1 Lower Cascade Canal Site 1 Tree Health Assessment Data

In Monitoring Year 10, 14 riparian trees were surveyed at Site 1 on the LCC on October 11, 2023, including bigleaf maple and Pacific dogwood. Four study trees were absent since the last survey largely due to tree thinning in the monitoring area (likely by landowners). Most trees surveyed had full to partial canopy cover and good bark health, and exhibited DBH growth, new growth, surface growths, some foliage discoloration, and insect damage. Disease and parasites were minimal at this site; however a few tree trunks were encroached by honeysuckle. Overall tree health at Site 1 was good, with a range of health scores from 8 to 14 and an average health score of 11 (Table 4-1, Graph 4-1).

General site conditions included down woody debris in the understory on both up and downslope portions of Site 1. As noted above, there was evidence of tree thinning in the monitoring area, as well as continuing thinning downslope from the monitoring area during the surveys. Various upland tree species are also present at Site 1, including Douglas-fir, beaked hazelnut, incense cedar, and Pacific madrone (Appendix F).

Since Baseline Year 0, trees at Site 1 improved from partial to medium to full canopy cover, and bark health remained good. However, presence of insects increased from barely present at Site 1 to present in most trees. Presence of new growth greatly decreased from Baseline Year 0 to Monitoring Year 4 but made a substantial recovery in Monitoring Year 6 and sustained that into Monitoring Years 8 and 10. Surface growth remained highly prevalent, and diseases and parasites remained minimal across monitoring years. Two tree deaths were observed at Site 1 between Baseline Year 0 and 6, and three new trees were confirmed dead in Monitoring Year 8. In 2023, five tree deaths were confirmed. There was fuel reduction and tree thinning being conducted adjacent to the monitoring site in 2023; however, it appears that some of the trees included in the study were removed as well. In comparison with Monitoring Year 8, trees surveyed in Monitoring Year 10 exhibited overall increases in DBH and new growth. Overall tree health at Site 1 remains good since Baseline Year 0, oscillating on health between Monitoring Years 2 through 10 (Table 4-1, Graph 4-1). Although five more trees were found dead or were missing, the other surviving trees are showing better health at this site as compared to Monitoring Years 4 and 6 and the same health as Monitoring Year 8. The five trees that were missing/dead this past year were primarily due to the forest thinning project and had been removed.

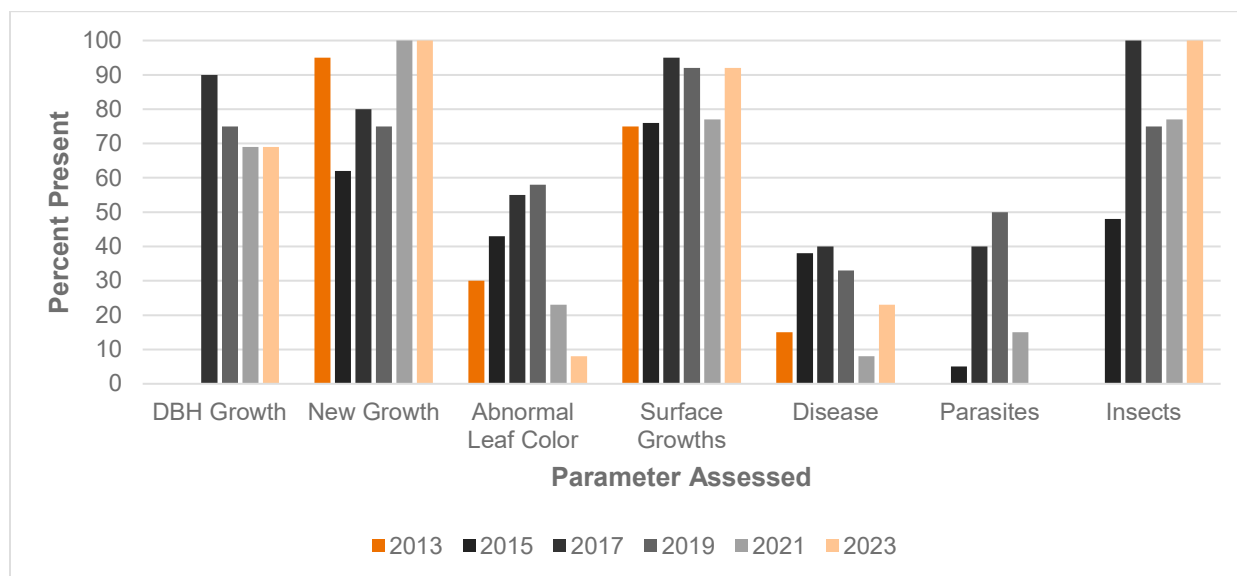
Graph 4-2. Lower Cascade Canal Site 2 Tree Health Assessment Data

During Year 10 monitoring, 13 riparian trees were surveyed at Site 2 on the LCC on October 12, 2023. Tree species surveyed include bigleaf maple, gray alder, and Pacific dogwood. No new trees were found dead. Most trees surveyed had full to partial canopy cover and good bark health, and exhibited new growth, surface growths, and insect damage and infestation. Disease was minimal at this site, but approximately half the trees surveyed exhibited foliage discoloration and parasites such as honeysuckle and Himalayan blackberry on trunks and branches. Overall tree health at Site 2 is good, with a range of health scores from 7 to 13 and an average health score of 11 (Table 4-2, Graph 4-2).

General site conditions included excessive encroachment by non-native understory species (e.g., Himalayan blackberry), as noted in previous years. Mechanical removal of upslope study trees in 2018 and installation of fencing by private landowners rendered the upslope portion of the site inaccessible. As such, the upslope trees are no longer a part of the study. Drainage fed by the LCC and rainfall/runoff was observed near trees surveyed downslope of the LCC; water was present at the time of the survey this year. Various upland tree species are also present at Site 2, including black oak, beaked hazelnut, and incense cedar.

Since Baseline Year 0, canopy cover of trees at Site 2 remained consistent, and bark health varied over the years but remained in the good health category in Monitoring Year 8. DBH growth has steadily declined since Baseline Year 0 and then was consistent between Monitoring Years 8 and 10, however new growth has oscillated over the years and increased in Monitoring Years 8 and 10. Abnormal leaf color and parasites decreased during Monitoring Year 10, however surface growths, diseases, and insect presence increased. Only one tree death was observed at Site 2 since Baseline Year 0, and no new trees were confirmed dead in Monitoring Year 10. In comparison with Monitoring Year 8, trees surveyed in Monitoring Year 10 exhibited consistent DBH growth and new growth, and less abnormal leaf color and parasites. However, there was an increased presence of surface growth, disease, insects and insect damage. Overall tree health at Site 2 remains good since Baseline Year 0, with a slight decrease between Monitoring Years 2 through 6 (Table 4-2, Graph 4-2), but increasing in Monitoring Years 8 and 10.

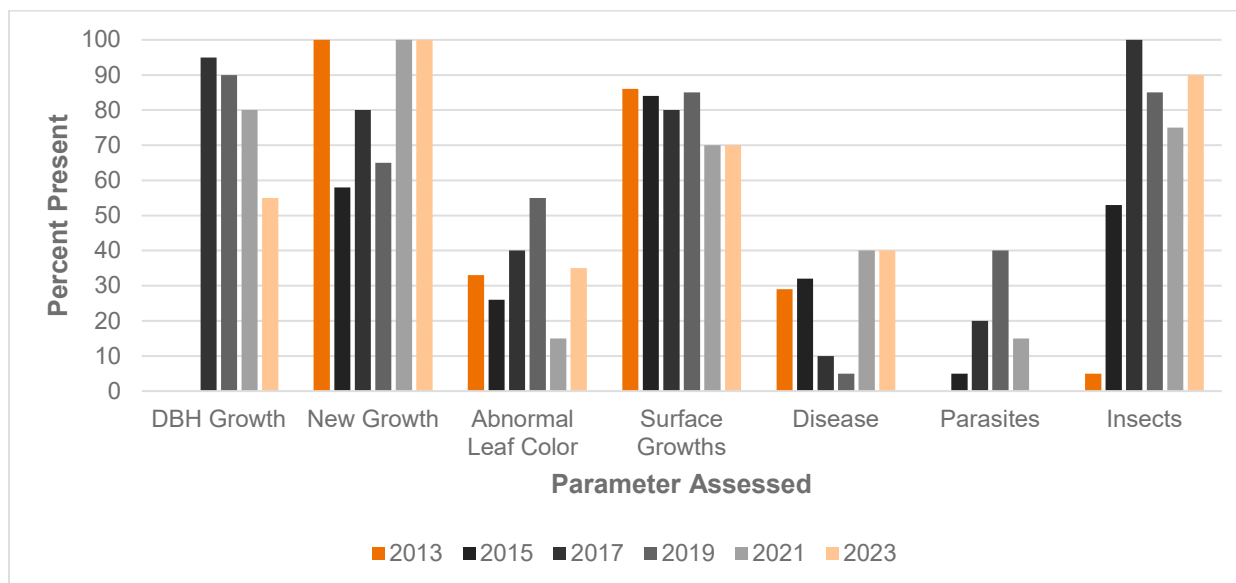
Graph 4-3. Lower Cascade Canal Site 3 Tree Health Assessment Data

During Monitoring Year 10, 20 riparian trees were surveyed at Site 3 on the LCC on October 12, 2023. Tree species surveyed include bigleaf maple, gray alder, and Pacific dogwood. No new trees were found dead. Most trees surveyed had full to partial canopy cover and good bark health. Trees exhibited some surface growth, in the presence of and insect damage and infestation. The trees exhibited new growth. Disease amongst some of the trees was observed at this site, in addition to presence of parasites. Additionally, California wild grape and English ivy were present on several tree trunks and branches. Some abnormal leaf color was observed. Overall tree health at Site 3 was good, with a range of health scores from 4 to 14 and an average health score of 10 (Table 4-3, Graph 4-3).

General site conditions included encroachment by non-native and invasive understory species that also were vining up the tree trunks (e.g., English ivy). Various upland tree species are also present at Site 3, including Douglas-fir and incense cedar.

consistently prevalent, although slightly decreased in Monitoring Year 8 and stayed consistent in Year 10. No tree deaths were observed at Site 3 since Baseline Year 0. In comparison with Monitoring Year 8, trees surveyed in Monitoring Year 10 exhibited a reduction in parasites. The trees surveyed exhibited less growth in DBH and a greater presence of abnormal leaf color and insect damage. There was consistence between new growth, surface growth, and disease between Monitoring Year 8 and Monitoring Year 10. Overall tree health at Site 3 remained consistently good in Monitoring Year 10 (Table 4-3, Graph 4-3).

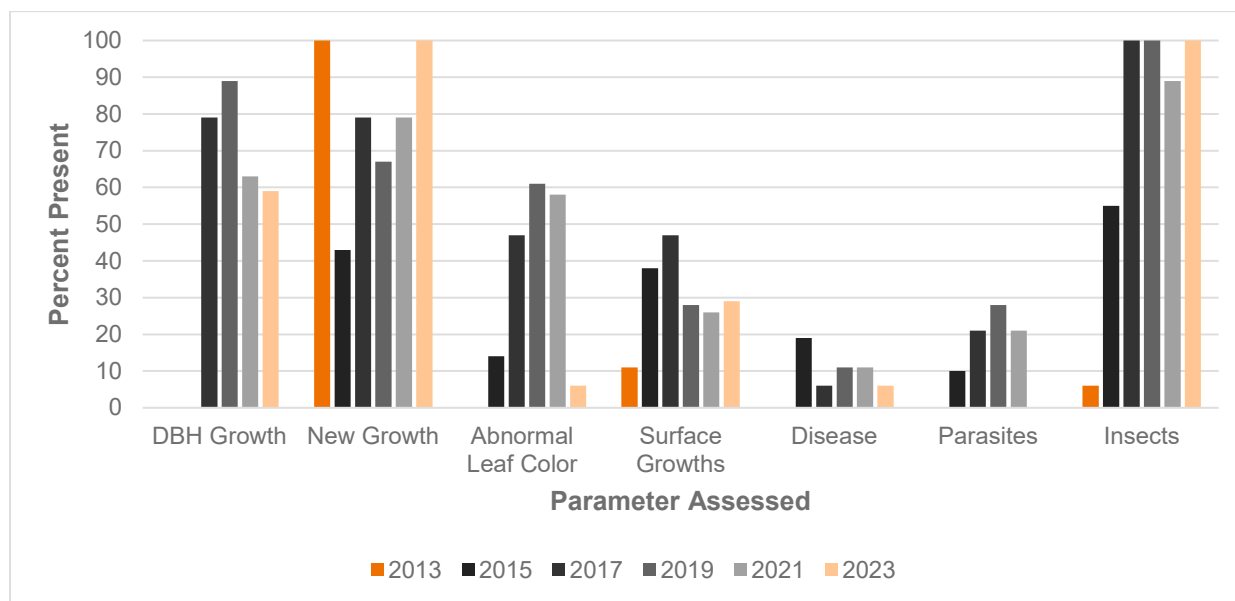
Graph 4-4. Lower Cascade Canal Site 4 Tree Health Assessment Data

During Year 10 monitoring, 17 riparian trees were surveyed at Site 4 on the LCC on October 11, 2023. Tree species surveyed include bigleaf maple, gray alder, and Oregon ash. Two study trees were found dead. Most of the trees surveyed exhibited insect damage and infestation. On average, trees surveyed had full to partial canopy cover and good bark health, and over half the trees surveyed exhibited new growth. Disease, abnormal foliage discoloration, surface growth, and parasites were minimal at this site, though English ivy and root rot were present on some tree trunks. Overall tree health at Site 4 is good, with a range of health scores from 9 to 13 and an average health score of 12 (Table 4-4, Graph 4-4).

General site conditions included beaked hazelnut, thimbleberry (*Rubus parviflorus*), and poison oak. Various upland tree species are also present at Site 4, including black oak, Douglas-fir, incense cedar, and tanoak.

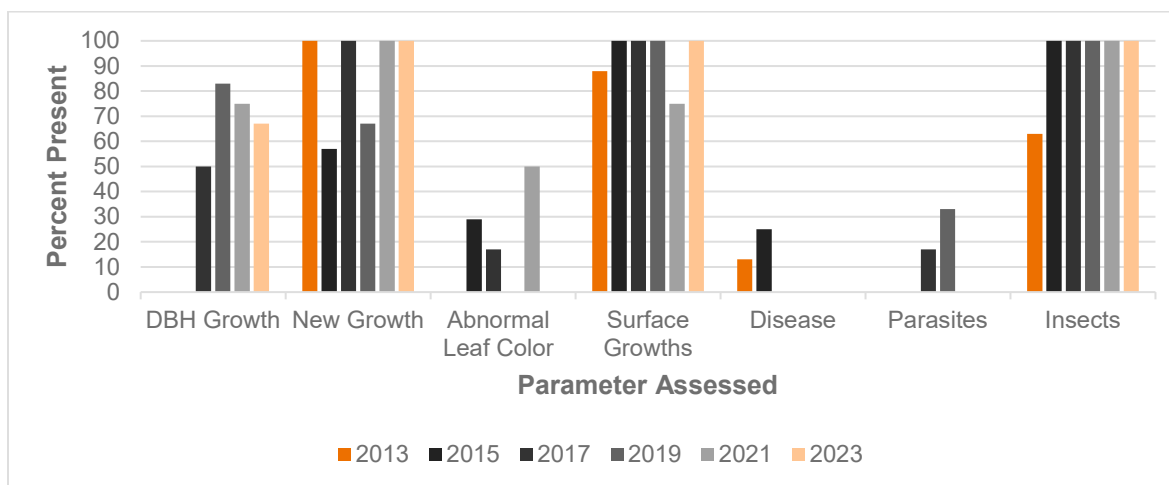
Graph 4-5. Upper Grass Valley Canal Site 5 Tree Health Assessment Data

During Year 10 monitoring, three riparian trees were surveyed at Site 5 on the UGVC on October 16, 2023. Tree species surveyed include bigleaf maple, Pacific dogwood, and white alder. One additional tree appeared to have been mechanically removed due to a tree thinning project. All trees surveyed exhibited insect damage and infestation, but also new growth. Most trees surveyed exhibited full to partial canopy cover, excellent bark health, and no disease. There was no presence of abnormal foliage discoloration. Parasitic honeysuckle was present on some tree trunks and adjacent saplings. Mechanical damage to trees from roadside tree-trimming was observed, as well as new growth of various riparian tree species saplings within the site. Overall tree health at Site 5 is good, with a range of health scores from 9 to 12 and an average health score of 10 (Table 4-5, Graph 4-5).

General site conditions included some mechanical damage to trees due to proximity to the road. Various upland tree species are also present at Site 5, including black oak and incense cedar.

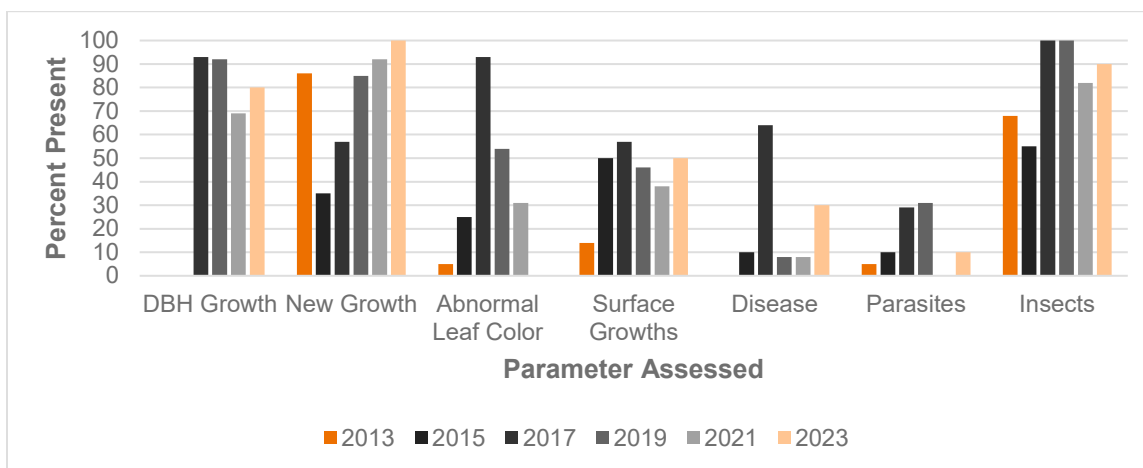
Graph 4-6. DS Canal Site 6 Tree Health Assessment Data

General site conditions included multiple down large woody debris from the previous winter's snowfall, and vining plant encroachment on tree trunks primarily by honeysuckle. Various upland tree species are also present at Site 6, including Douglas-fir, incense cedar, and Ponderosa pine.

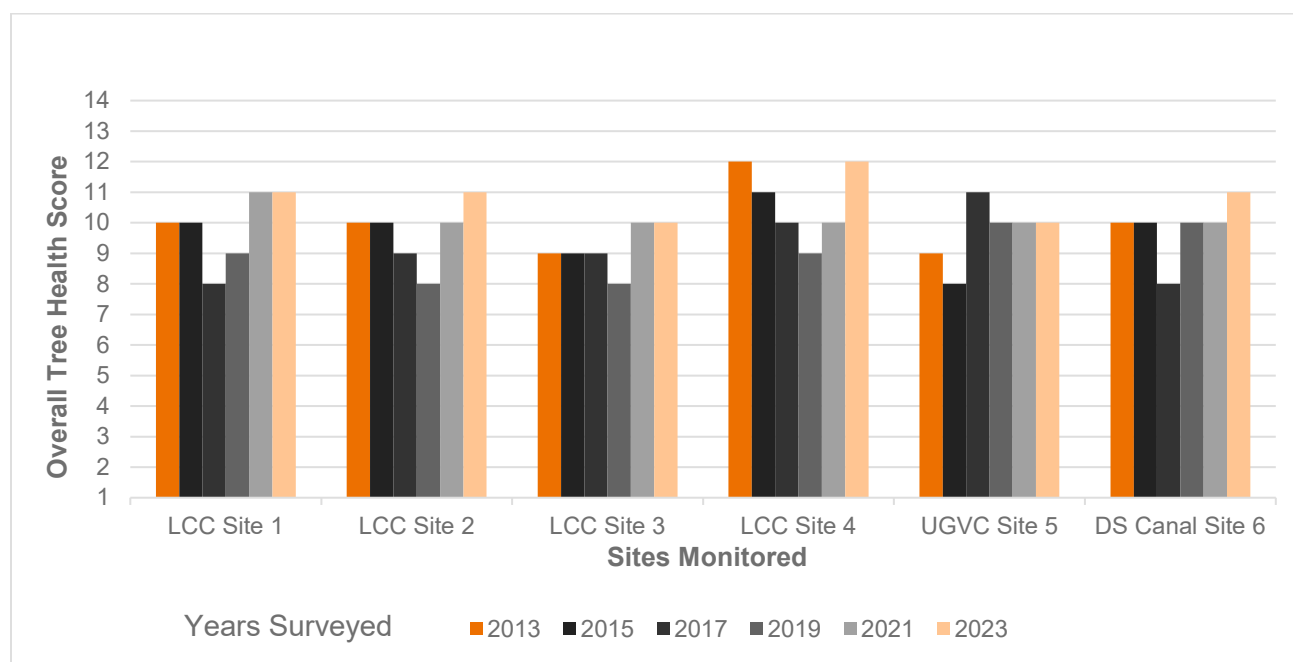
Graph 4-7. Average Overall Tree Health Scores⁷ by Study Site

Overall tree health at Sites 2 and 4 on the LCC increased from Monitoring Years 8 to 10 (Graph 4-7). Overall tree health at Sites 1 and 3 on the LCC was consistent from Monitoring Years 8 to 10. Health on the UGVC and DS Canal were consistent and even slightly increased between Monitoring Years 8 and 10. The overall tree health is higher at Site 4 than any of the other sites. Slightly decreased growth in DBH as compared to previous years was the only negative factor amongst the sites in Monitoring Year 10 as compared to previous years. Otherwise, canopy cover remained consistent at all sites, so it can be concluded that associated riparian shade canopy remains intact. There was a slight decrease in Canopy Cover along the UGVC but it is still consistent with Baseline Monitoring Year 0. There has been some limb trimming on those trees due to the adjacency to the roadway (UGVC runs parallel to Banner Lava Cap Road). There was minimal loss of riparian tree species along the LCC study sites the first 8 years of the study; however, due to tree thinning and a heavy winter storm in early 2023, there were more riparian tree deaths in Monitoring Year 10 than the last 8 years combined. From Monitoring Year 0 to 8, there were seven total confirmed tree deaths (primarily at LCC Site 1) out of 84 trees total amongst the sites for the duration of the study. This year (differing from the previous 8 years), more trees were mechanically removed and/or crushed by fallen conifers. There was a total of eight tree deaths during Monitoring Year 10 (five of which occurred at Site 1). It can be concluded (due to observed factors and comparing to that of the reference site) that the tree deaths were due to outside affects, not as a result of the lowered flows in the canal. Despite the increase in tree death, the remaining trees had a 100 percent rate of new growth observations (i.e., riparian forest regeneration) rebounding to baseline levels.

Overall tree health at DS Canal slightly increased from Monitoring Year 8 to 10, and also increased slightly from baseline overall health levels (Graph 4-7). In Monitoring Year 10, overall tree health at Site 6 was consistent with Sites 1 and 2 on the LCC and slightly higher than at LCC Site 3 and UGVC Site 5. It had slightly lower tree health than at LCC Site 4. Increased presence of new growth, canopy cover, bark health, and a decrease of abnormal leaf color on the trees are the primary drivers leading to increased overall health at Site 6. Canopy cover and bark health generally increased from Baseline Year 0, so it may be concluded that associated riparian shade canopy remains intact. Over the past 10 years, there was a moderate loss of riparian tree species at Site 6, with nine total confirmed tree deaths out of 22 trees. Site 6 had a high loss of trees (three in total) in 2023 due to large conifers falling on the smaller riparian trees as a result of storm damage from a heavy snowfall in February 2023.

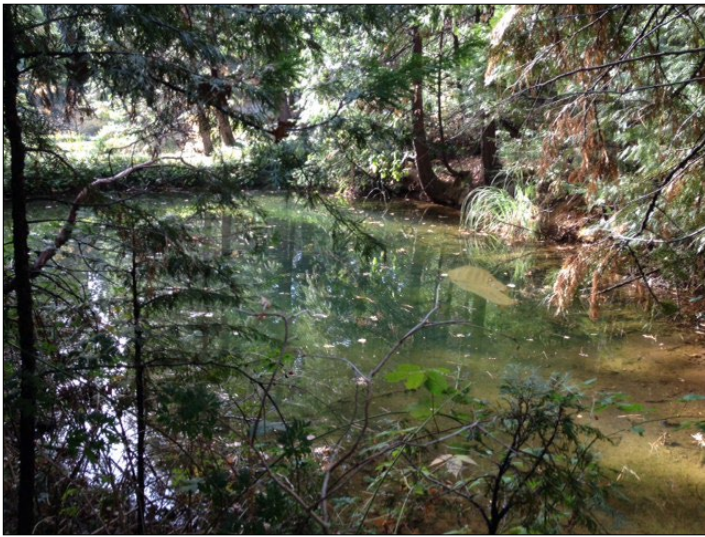
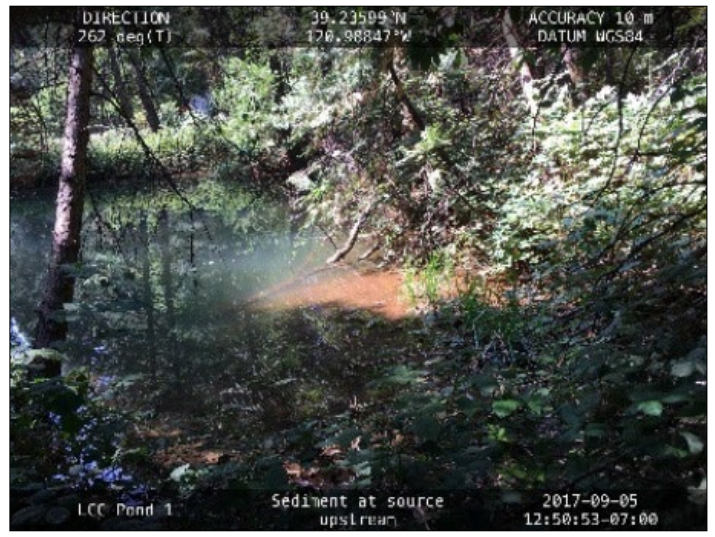
Photograph 56: 2017. LCC Pond 1. Southwest facing aspect. Sedimentation present from inlet.
