# Staff Report

**SUBJECT:** **Badger Meter Technology Presentation**

# NID Meter Replacement Program

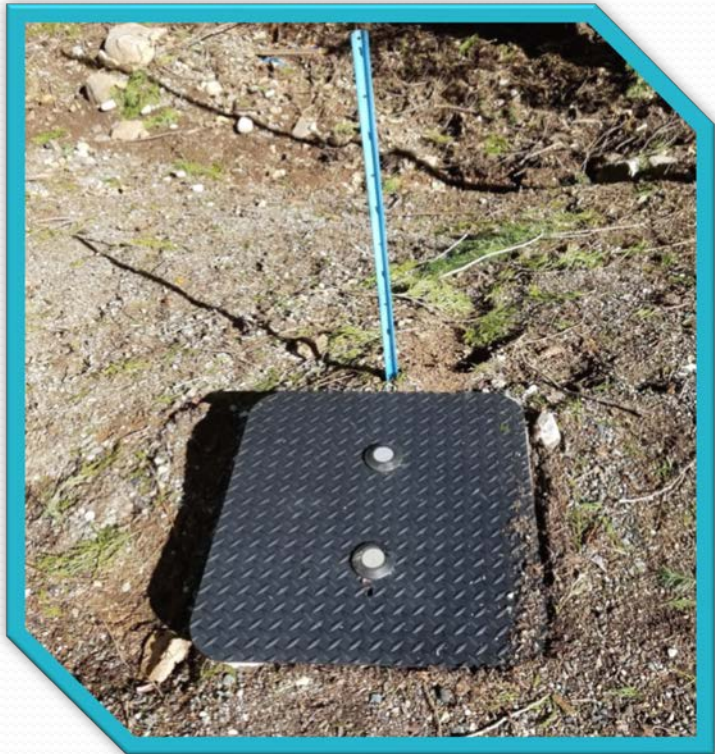
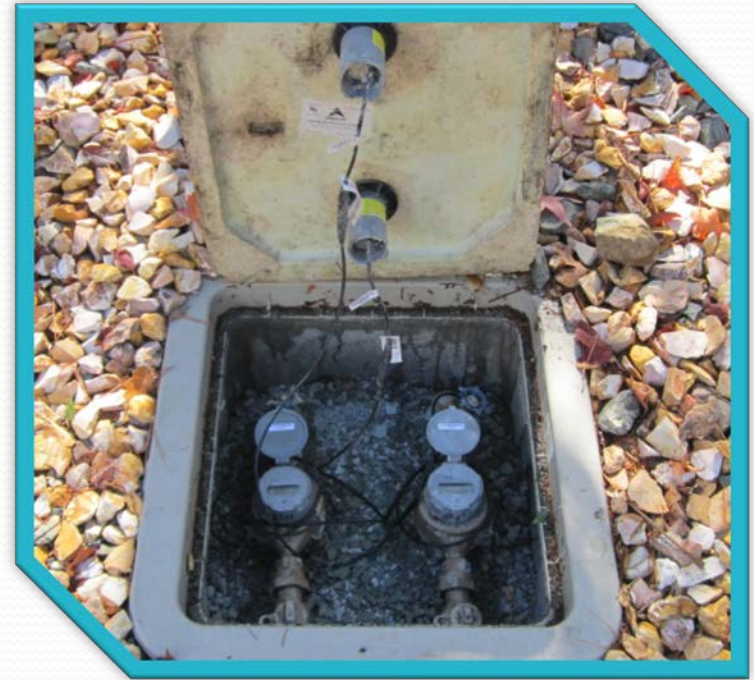
# Converting to Badger Meters

- Approximately 6,380 Badger meters installed as of June 18<sup>th</sup>, 2019

- Existing meters are replaced when components fail

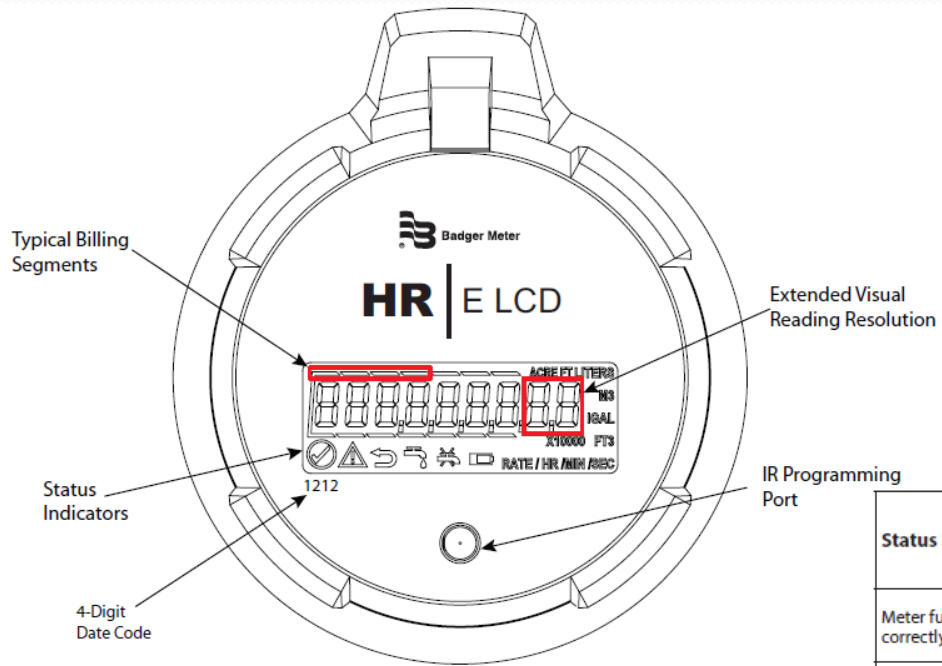
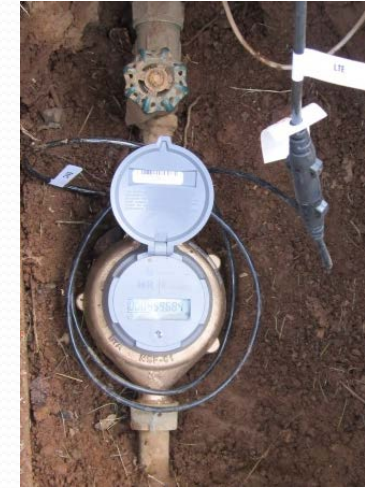
# BADGER METER

**Model 25 Disc Series Meter Calibrated in Gallons**

Status Indicator	Icon	Status Description	HR-E LCD Display	HR-E LCD with ORION Cellular or Fixed Network* and Migratable* Endpoints <small>*Firmware version 1.8 or higher required</small>
Meter functioning correctly		Encoder operating correctly.	Continuous display on encoder as long as no other status indicators are triggered.	Indicator status not sent to the endpoint.
Encoder alarm		Several potential conditions may exist, including: Encoder removal Temperature limit exceeded (34...140° F) Magnetic tamper	Encoder alarm remains active for 35 days. The alarm automatically clears after 35 days if any of the 3 conditions has not recurred.	Encoder alarm sent to the endpoint.
Reverse flow		Encoder detects reverse flow.	Reverse flow alarm remains active for 35 days. The alarm automatically clears after 35 days if reverse flow condition has not recurred.	Encoder detects reverse flow and sends alarm message to the endpoint.

Suspected leak		Encoder detects 24 hours without one 15-minute interval of no flow.	The alarm clears automatically when a 15-minute no-flow interval occurs.	Encoder detects suspected leak and sends alarm message to the endpoint. If condition clears before message is sent to the endpoint, it is not reported.
30 day no usage		No measured flow in past 30 days.	The alarm is automatically cleared once flow occurs.	Encoder detects 30 days no usage and sends alarm to the endpoint.
End of life battery indicator		Indicated battery life based on pre-calculated consumption.	Alarm activated at 19 years and does not clear.	Encoder sends alarm to the endpoint.

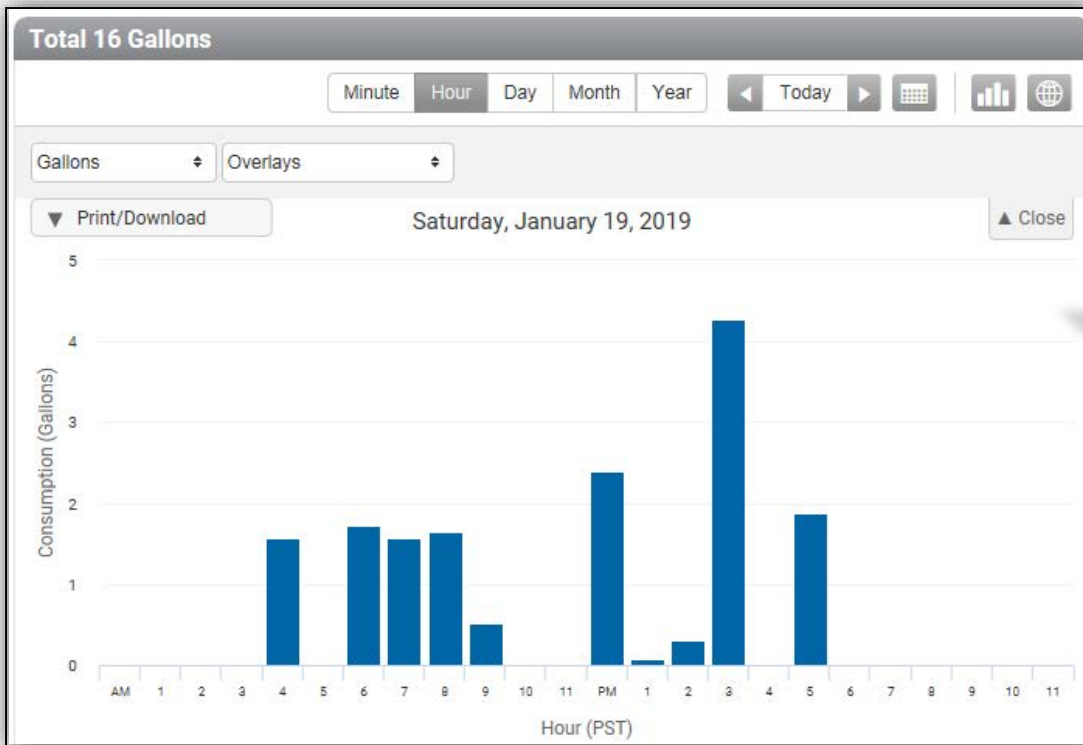
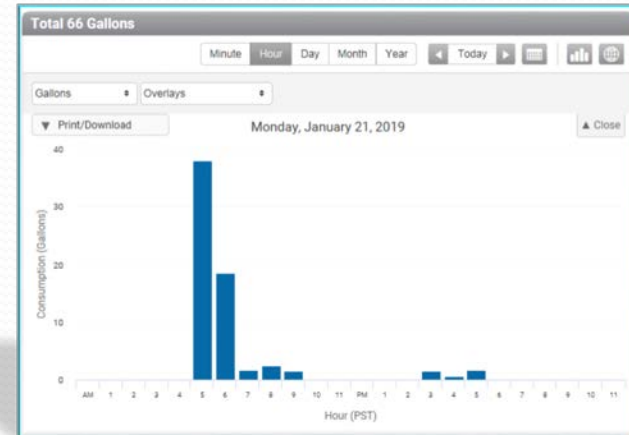
# Hour by Hour Water Use

An 1835 sq. ft. single family residence water use for  
January 19-21, 2019  
Average = 38 gallons per day

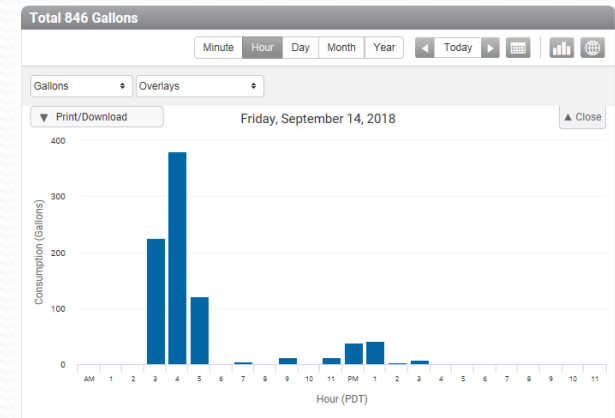
# I Used How Much Water?

The same single family residence water use for  
September 13-15, 2018  
Average = 634 gallons per day

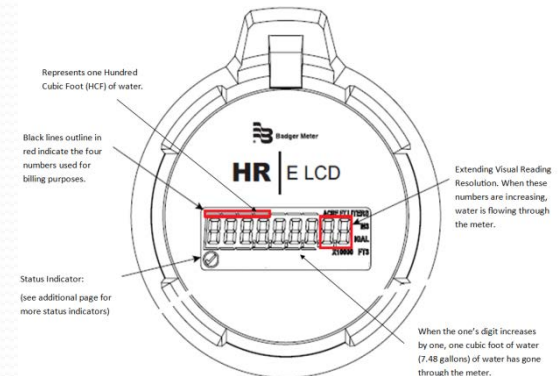
### Status Indicators:

Status Indicator	Icon	Status Description	HR-E LCD Display
Meter functioning Correctly		Register/encoder is operating correctly.	Continuous display on register/encoder as long as no other status indicators are triggered
Suspected Leak		Register/encoder detects 24 hours without one 15-minute interval of no flow.	The alarm clears automatically when a 15-minute no-flow interval occurs.

### Rate of Flow:

The rate of flow screen is in Gallons per minute. The displayed rate will be based on the average flow rate for the prior minute (since the last time the flow rate was displayed). This screen displays for 5 seconds.

If, there are numbers showing on this screen, and you were NOT running water. Water flowed through the meter when you were not using it.
