# Hydroelectric Department Monthly Update

Water & Hydroelectric Operations Committee February 9, 2021

#### Bowman Wind Event

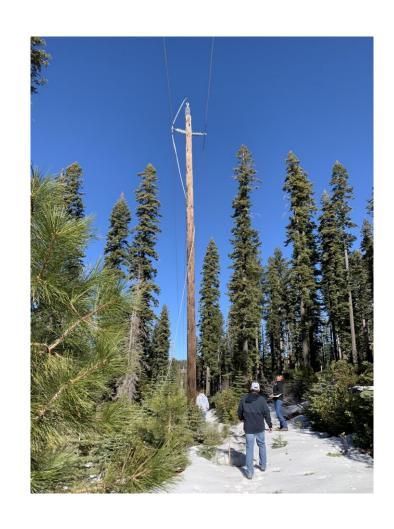
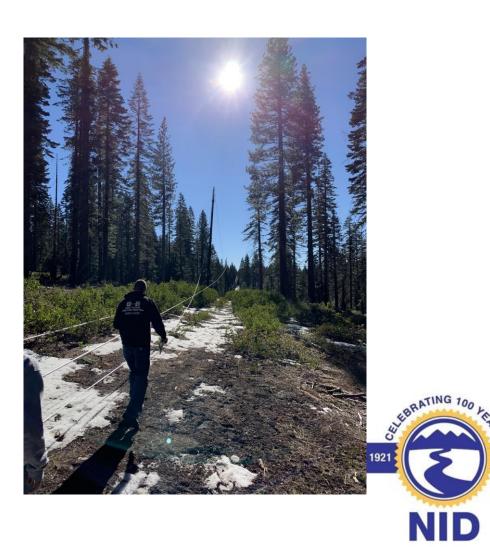
### Pole 86, 87, 88, and 89

Location	Damage Assessment	
Pole 51	Broken insulator.	
Poles 86, 87, 88, and 89	Multiple broken insulators, broken wire, wire on the ground.	
Pole 97, 98	Pole 98 destroyed. Insulator damage. Pole 97 leaning.	
Poles 100, 101, 102	Leaning/loose.	
Pole 127	Pole destroyed. Insulator damage.

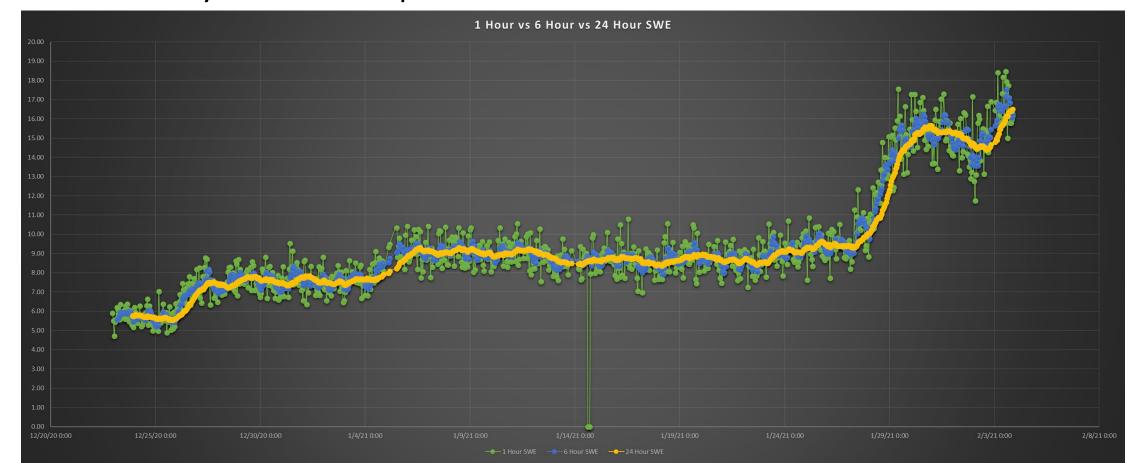
#### SnowFox

- Snow Water Equivalent (SWE) measurement using cosmic ray neutrons
- Near Jackson Meadows
- Preliminary data that requires calibration
