1883 DISASTER AT ENGLISH DAM – DFIC DECADE DAM FAILURE SERIES

CORY MIYAMOTO, P.E., SENIOR ENGINEER, CA DEPARTMENT OF WATER RESOURCES, DIVISION OF SAFETY OF DAMS; KEANE SOMMERS, P.E., DIRECTOR OF POWER SYSTEMS, NEVADA IRRIGATION DISTRICT; AND LACY CANNON, P.E., ASSOCIATE ENGINEER, NEVADA IRRIGATION DISTRICT

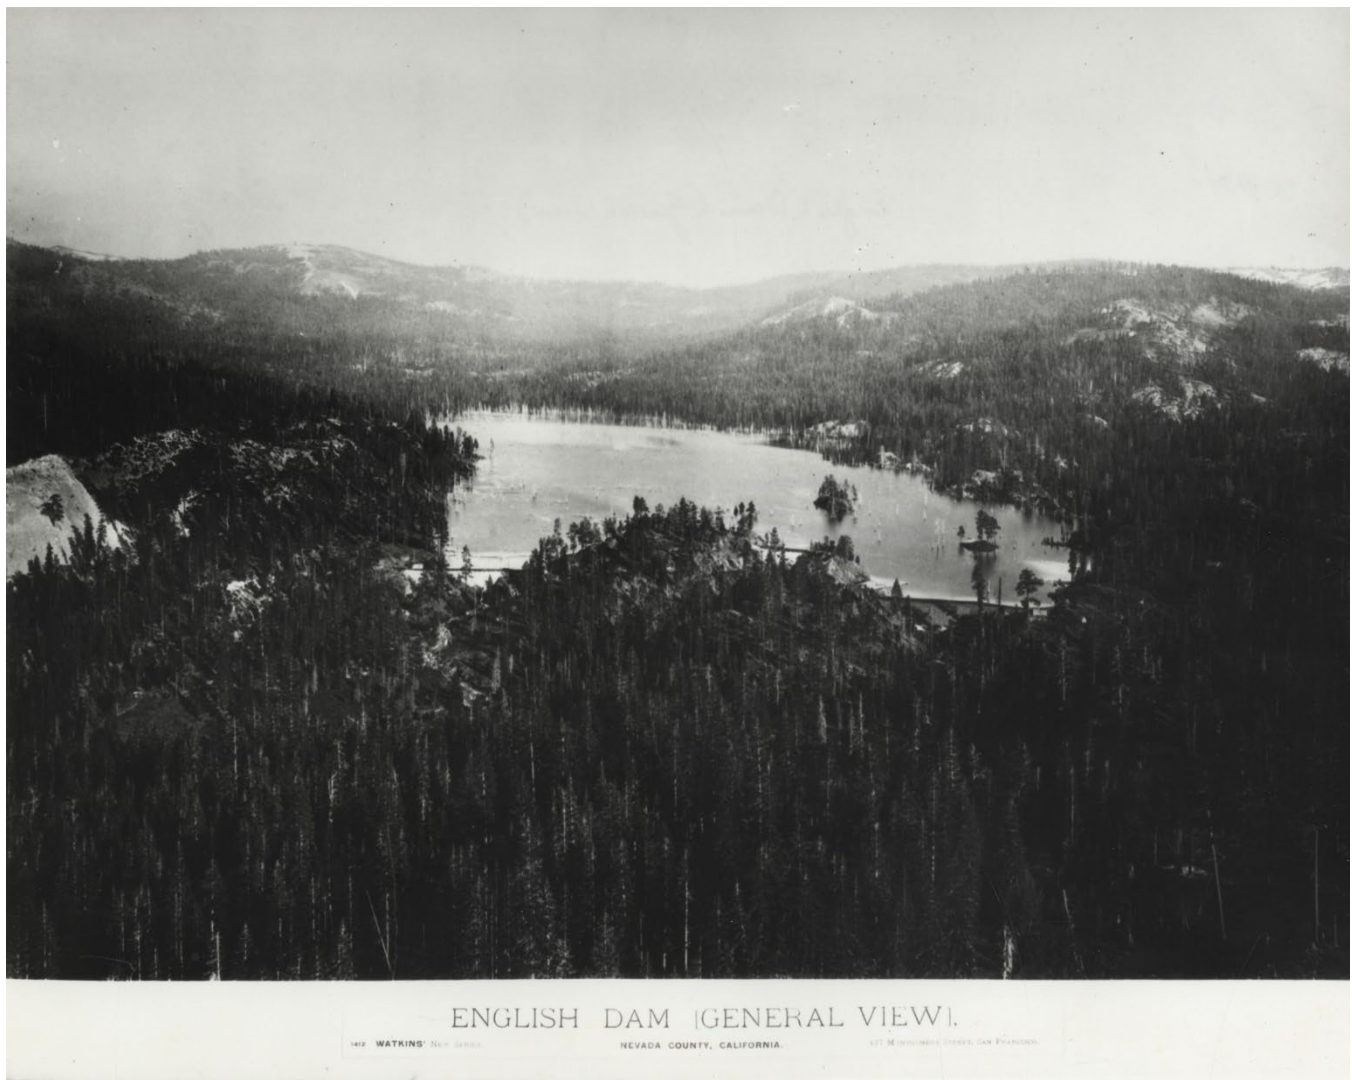
Figure 3. Overview of English Dam, c. 1871 (Source: California State University, Chico, Meriam Library Special Collections).

The East and West Saddle Dams (also referred to as the north and south dams [15]) were reportedly 50-feet and 60-feet high and 150-feet and 200-feet long, respectively. Both dams were approximately 40-feet wide at their base. A spillway was provided with spill crest 14-inches below the top of the upper cribwork. Observation of the remaining dam structure as it exists today (2023) as well as review of historic photographs (Figure 3) appear to indicate that the spillway was located at the East Saddle Dam.

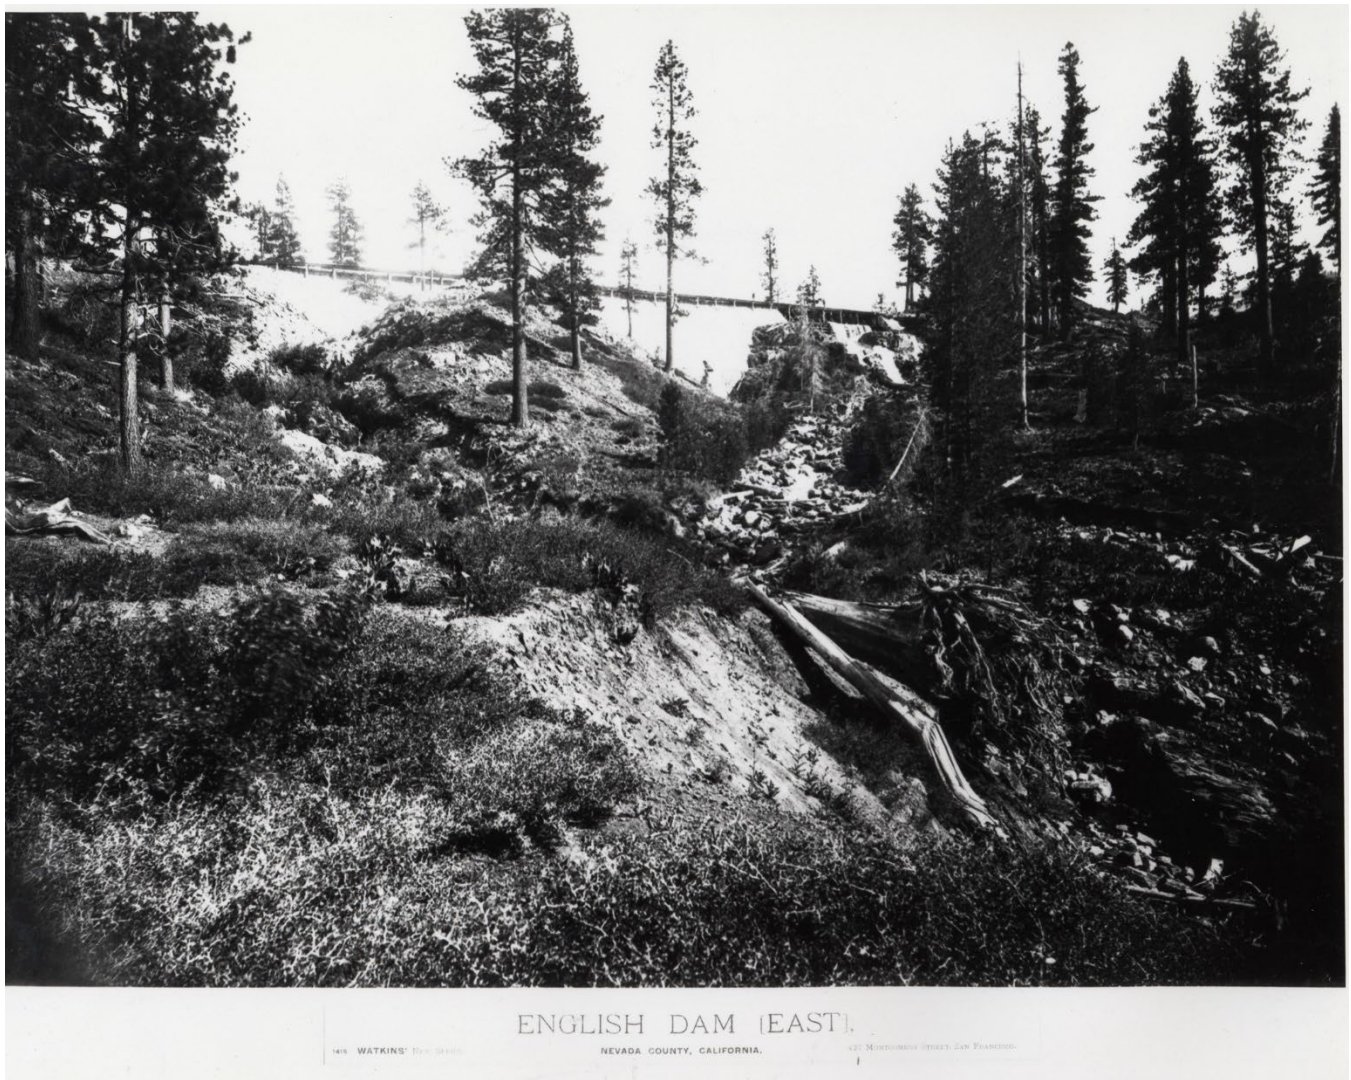
Figure 4. Overview of east saddle dam, c. 1871 (Source: California State University, Chico, Meriam Library Special Collections).

English Dam was composed of three timber crib and rockfill structures, including a main dam and two saddle dams (east and west). Historic photographs of the three structures are provided for reference in Figures 4-6. The Main Dam had an interior height of 100-feet, and exterior height of 131-feet. The base width was approximately 185-feet. The total length along the dam crest was estimated to be 331-feet, with a minimum bottom length of about 50-feet [1]. The original dam consisted of a rock-filled timber crib constructed of tamarack logs, 79-feet-high, 100-foot-thick at its base, and with an inner slope of 60-degrees [12]. The entire structure was faced with wooden planking.

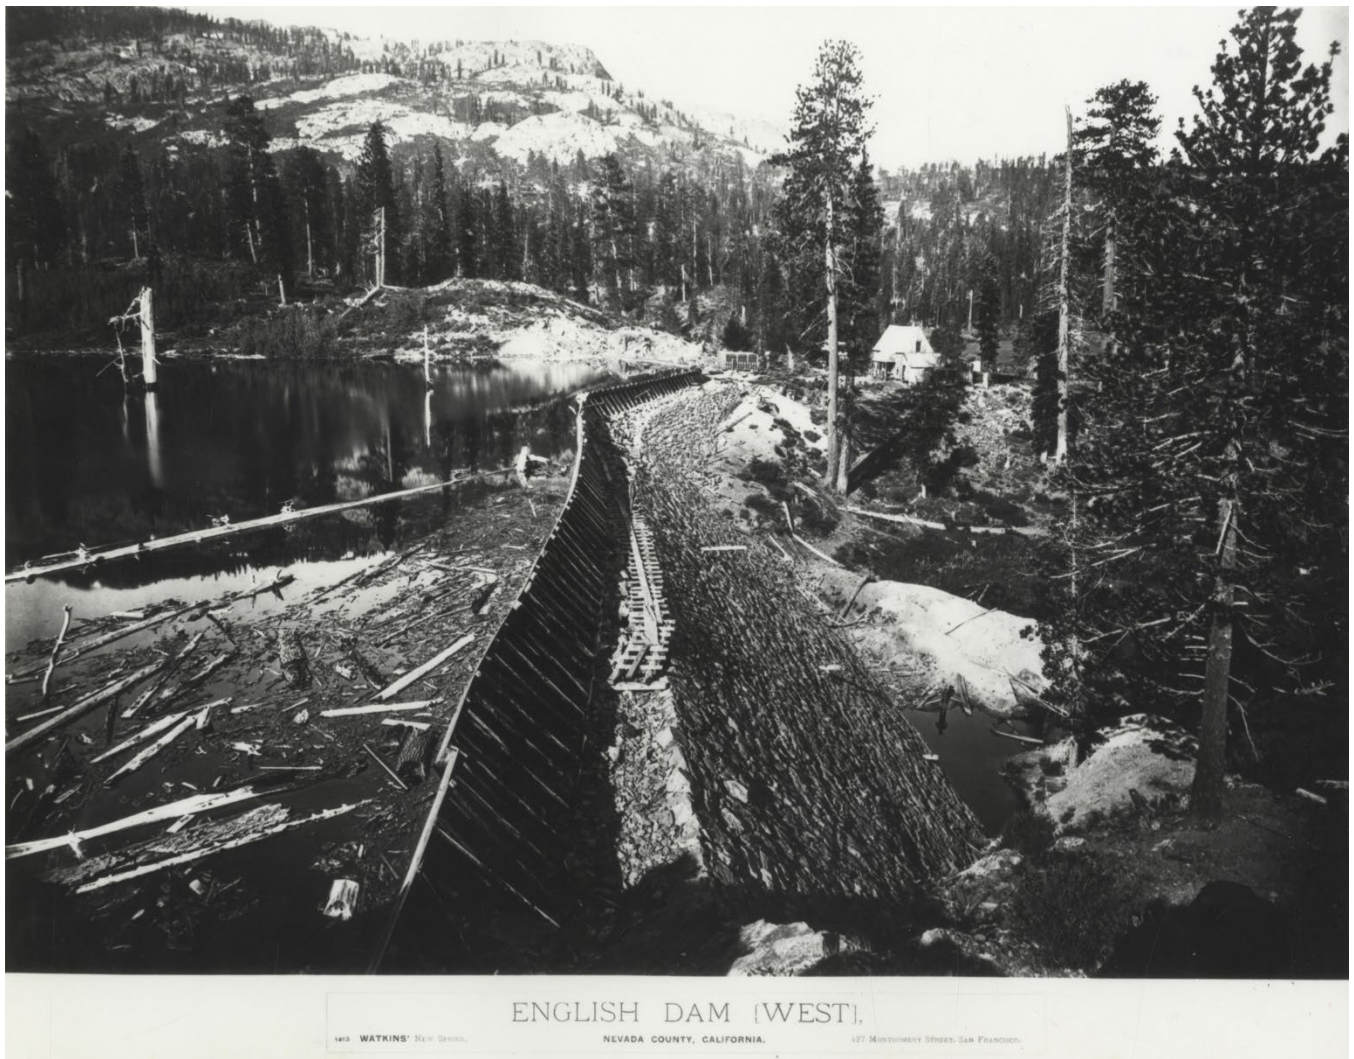
Figure 5. Overview of west saddle dam, c. 1871 (Source: California State University, Chico, Meriam Library Special Collections).

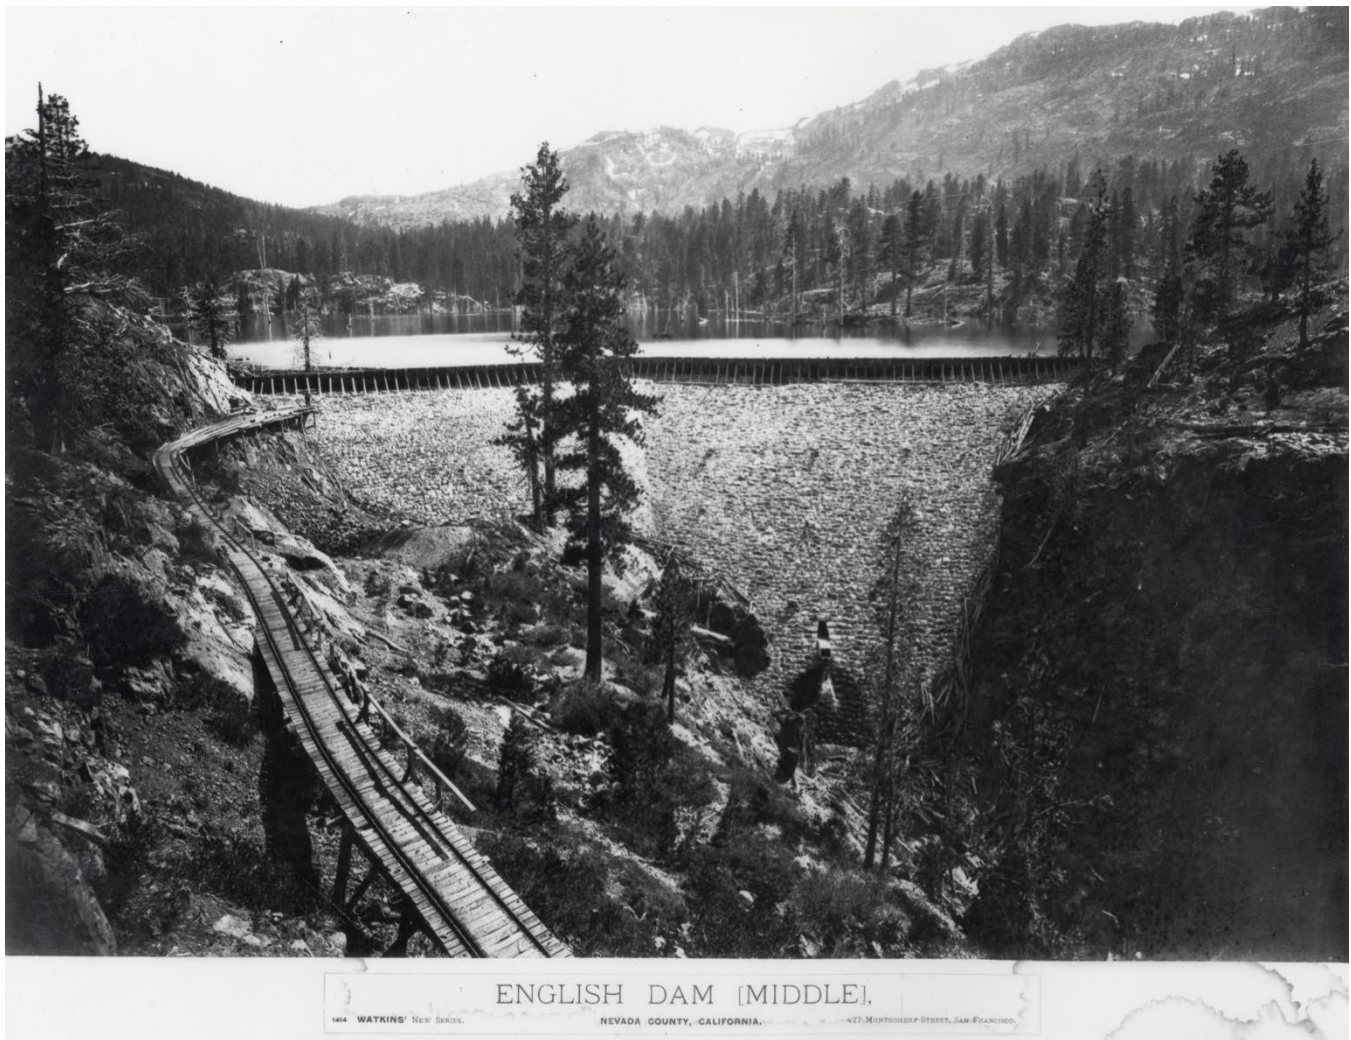
Figure 6. Overview of main dam, c. 1871 (Source: California State University, Chico, Meriam Library Special Collections).

In 1876-77, the structure was substantially repaired. Decayed portions of the timber crib were replaced with new timbers. At the same time, the dam was raised and thickened by building up a stone facing on the outside, laid up as a dry rubble wall at a slope of 44-degrees [12]. The total raise was approximately 14-feet above the original dam crest, with the upper 7-feet formed by a substantial timber crib work.

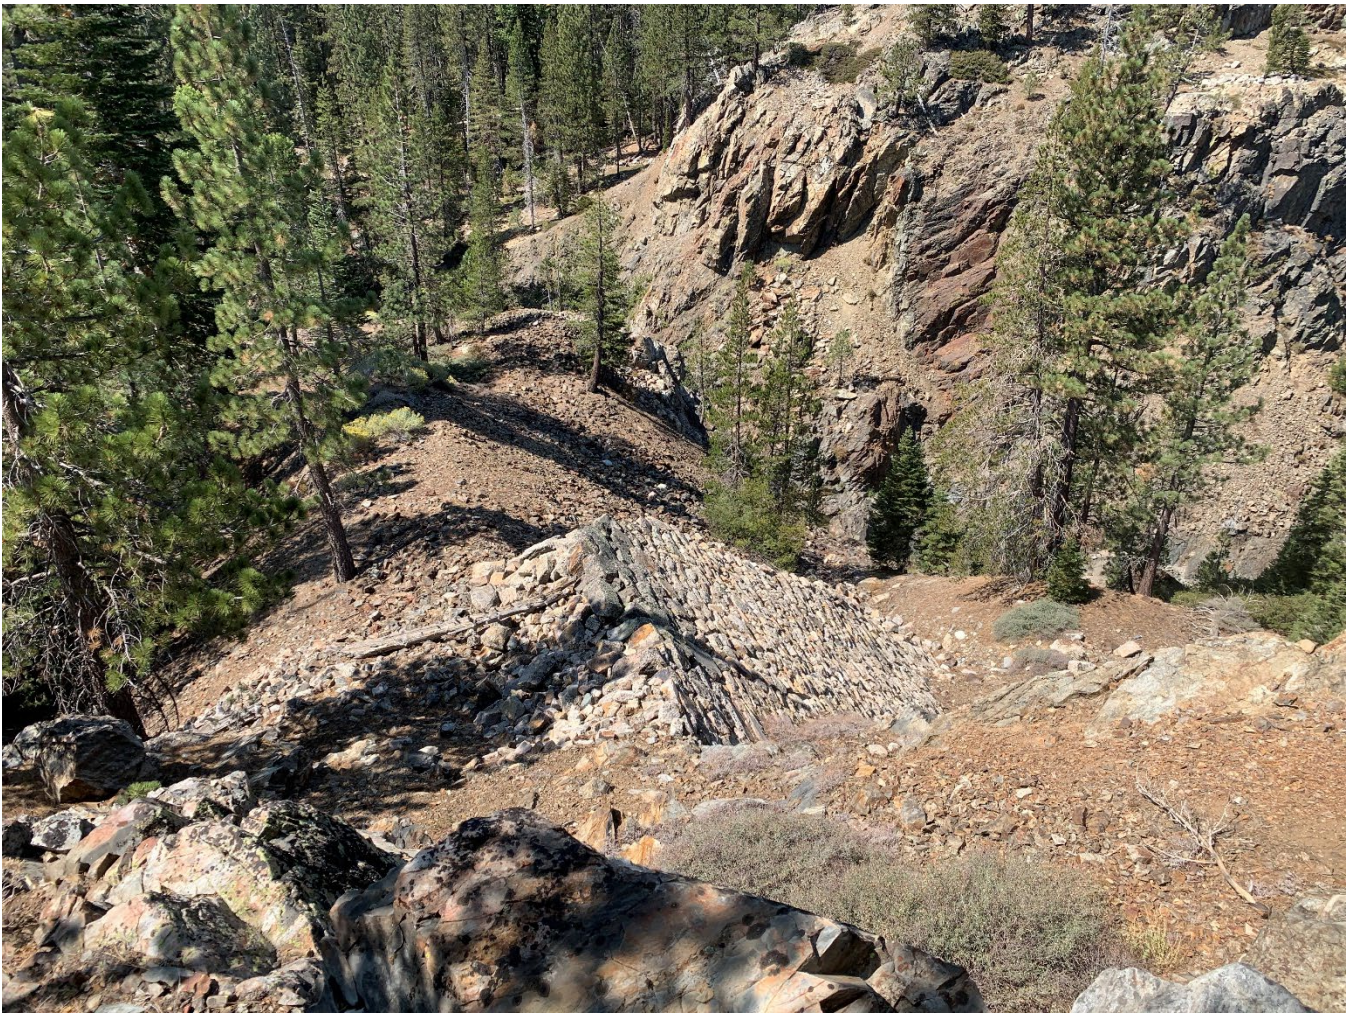
Figure 8. Remains of Middle English Dam looking southwest at the Middle Yuba River Canyon (Source: Nevada Irrigation District, Cameron Townsend).

English Dam was never rebuilt. A portion of the main dam and most of the two saddle dams still exist today (Figures 8 -10). Water rights to the Middle Yuba River, including the dam site, were acquired by NID in the 1920’s. The original dam site was considered again in the 1960’s during planning for NID’s Yuba-Bear Hydroelectric Power Project; however, construction of a new dam at the site was considered too costly. Furthermore, flows would be more effectively captured at the new (1965) Jackson Meadows Reservoir, just downstream [10]. NID continues habitat and hydrological restoration work at English Meadows (formerly inundated behind English Dam) to restore connectivity between the heavily incised Middle Yuba River and the floodplain. It is assumed that this disconnect is a result of the rapid draining of water following the dam’s failure.

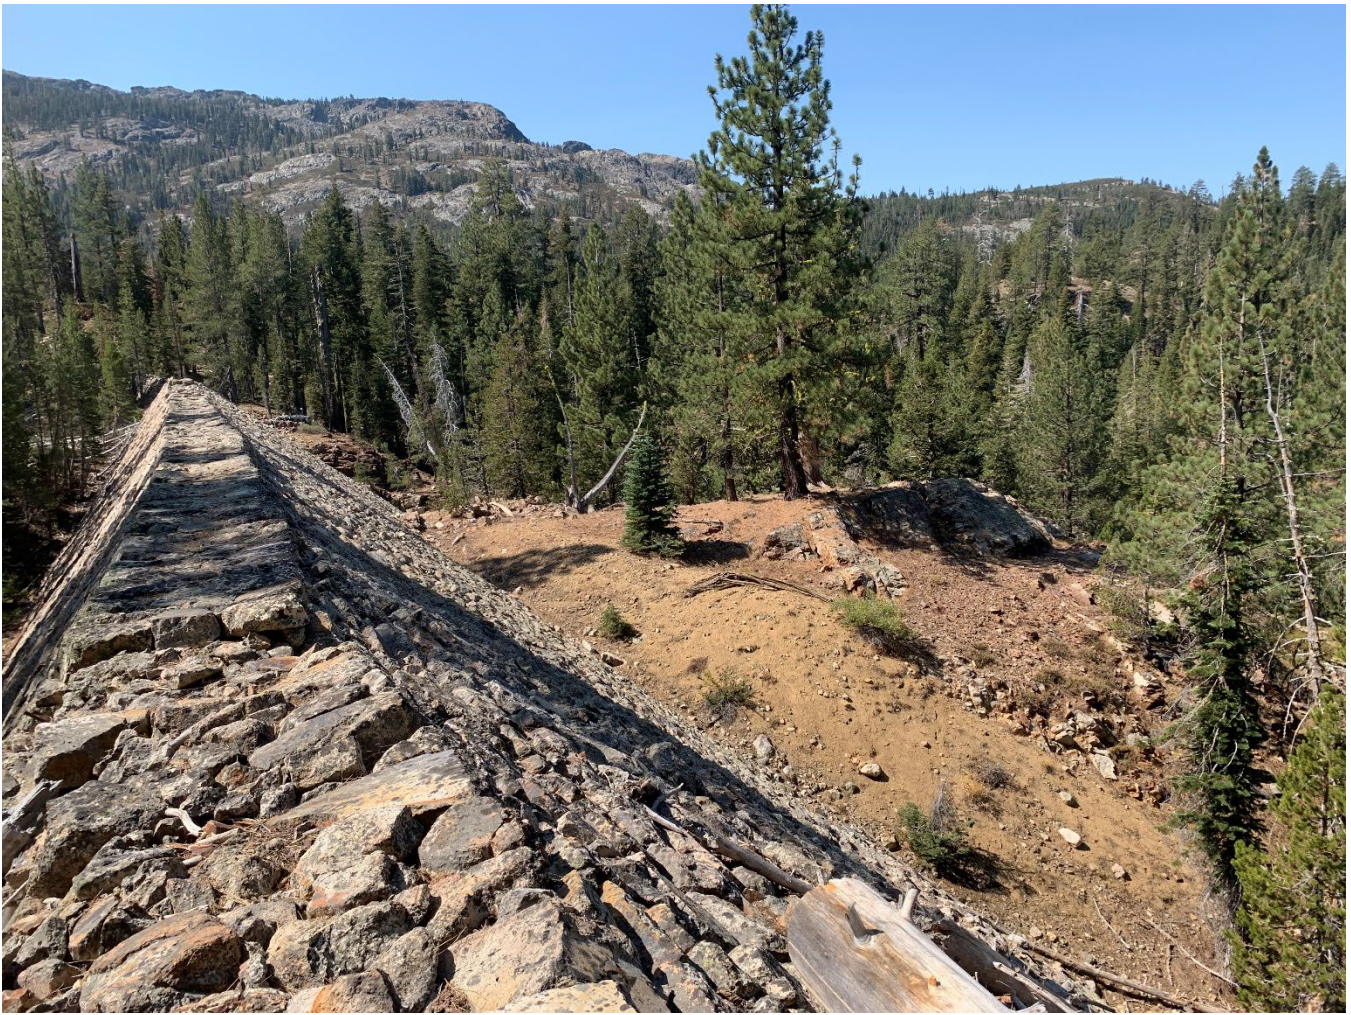
Figure 9. Remains of East Dam looking southwest (Source: Nevada Irrigation District, Cameron Townsend).

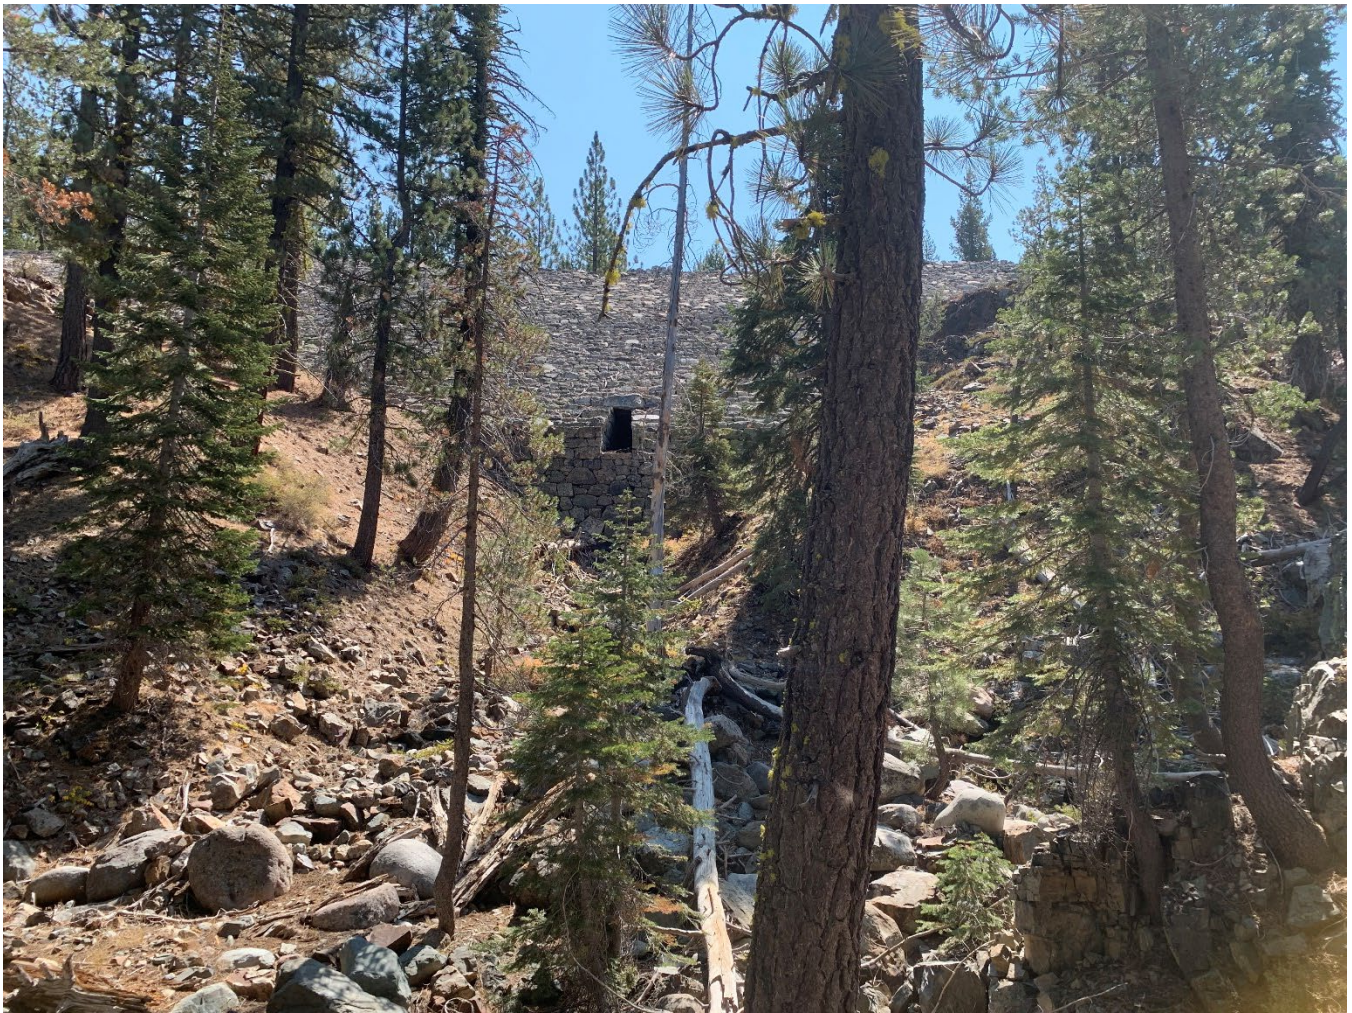
Figure 10. Remains of the East Dam looking upstream (Source: Nevada Irrigation District, Cameron Townsend).
