**NID Hydro Field Office Renovation**

**PROJECT NO. C0011**

**ADDENDUM NO. 1**

### SYSTEM RECORD OF INSPECTION AND TESTING

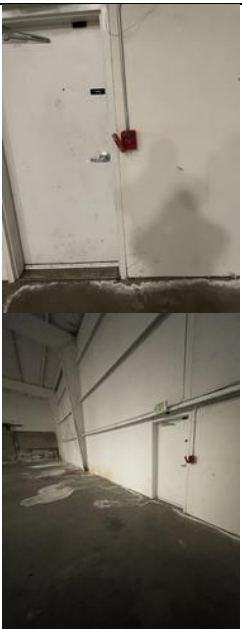
| DEFICIENCIES AND COMMENTS | | | | |
|---|---|---|---|---|
| Deficient | FACP | FACP Closet | Suite 148 S.E. Exit MPS has a broken cover. Replacement will be required. Part number BG-12 | |

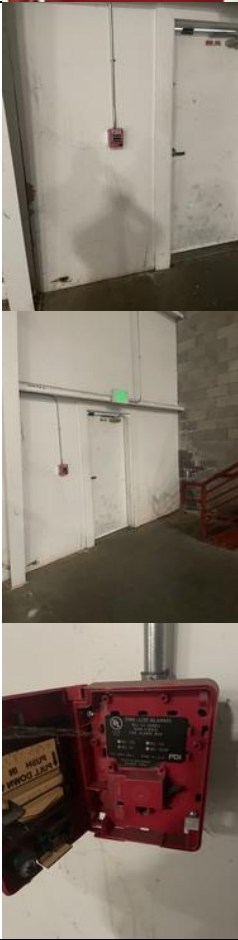
| Deficient | FACP | FACP Closet | Suite 148 N.E. Warehouse Exit MPS. Comes in as a supervisory. Will need to be reprogrammed. | |
