Staff Report

SUBJECT: Lower Cascade Canal and Upper Grass Valley Canal Tree Health, Canopy Cover and Pond Monitoring Report – Year 10 (Project No. 6593-2)

BANNER CASCADE PIPELINE PROJECT TREE HEALTH, CANOPY COVER, AND POND MONITORING REPORT – YEAR 10

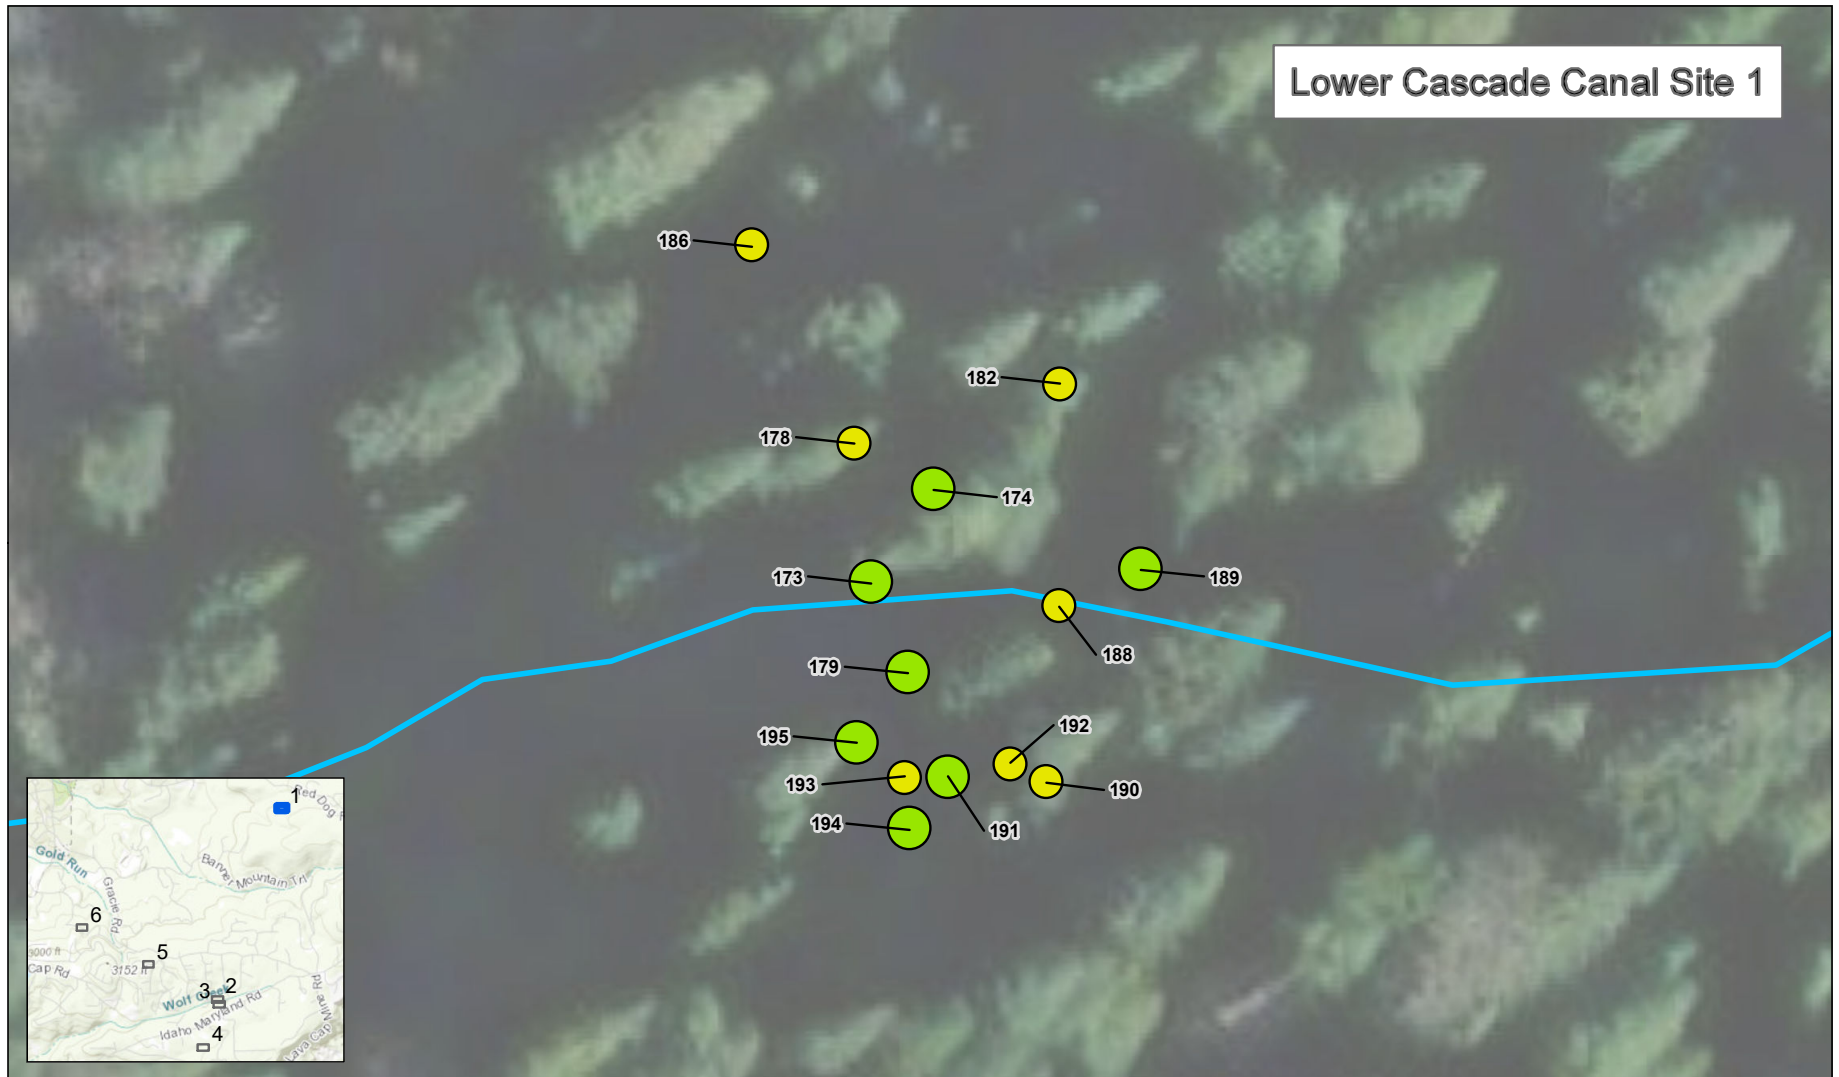
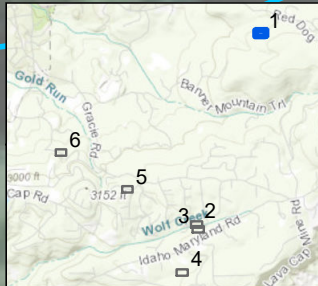
Lower Cascade Canal Site 1

In Monitoring Year 10, 14 riparian trees were surveyed at Site 1 on the LCC on October 11, 2023, including bigleaf maple and Pacific dogwood. Four study trees were absent since the last survey largely due to tree thinning in the monitoring area (likely by landowners). Most trees surveyed had full to partial canopy cover and good bark health, and exhibited DBH growth, new growth, surface growths, some foliage discoloration, and insect damage. Disease and parasites were minimal at this site; however a few tree trunks were encroached by honeysuckle. Overall tree health at Site 1 was good, with a range of health scores from 8 to 14 and an average health score of 11 (Table 4-1, Graph 4-1).

General site conditions included down woody debris in the understory on both up and downslope portions of Site 1. As noted above, there was evidence of tree thinning in the monitoring area, as well as continuing thinning downslope from the monitoring area during the surveys. Various upland tree species are also present at Site 1, including Douglas-fir, beaked hazelnut, incense cedar, and Pacific madrone (Appendix F).

Since Baseline Year 0, trees at Site 1 improved from partial to medium to full canopy cover, and bark health remained good. However, presence of insects increased from barely present at Site 1 to present in most trees. Presence of new growth greatly decreased from Baseline Year 0 to Monitoring Year 4 but made a substantial recovery in Monitoring Year 6 and sustained that into Monitoring Years 8 and 10. Surface growth remained highly prevalent, and diseases and parasites remained minimal across monitoring years. Two tree deaths were observed at Site 1 between Baseline Year 0 and 6, and three new trees were confirmed dead in Monitoring Year 8. In 2023, five tree deaths were confirmed. There was fuel reduction and tree thinning being conducted adjacent to the monitoring site in 2023; however, it appears that some of the trees included in the study were removed as well. In comparison with Monitoring Year 8, trees surveyed in Monitoring Year 10 exhibited overall increases in DBH and new growth. Overall tree health at Site 1 remains good since Baseline Year 0, oscillating on health between Monitoring Years 2 through 10 (Table 4-1, Graph 4-1). Although five more trees were found dead or were missing, the other surviving trees are showing better health at this site as compared to Monitoring Years 4 and 6 and the same health as Monitoring Year 8. The five trees that were missing/dead this past year were primarily due to the forest thinning project and had been removed.

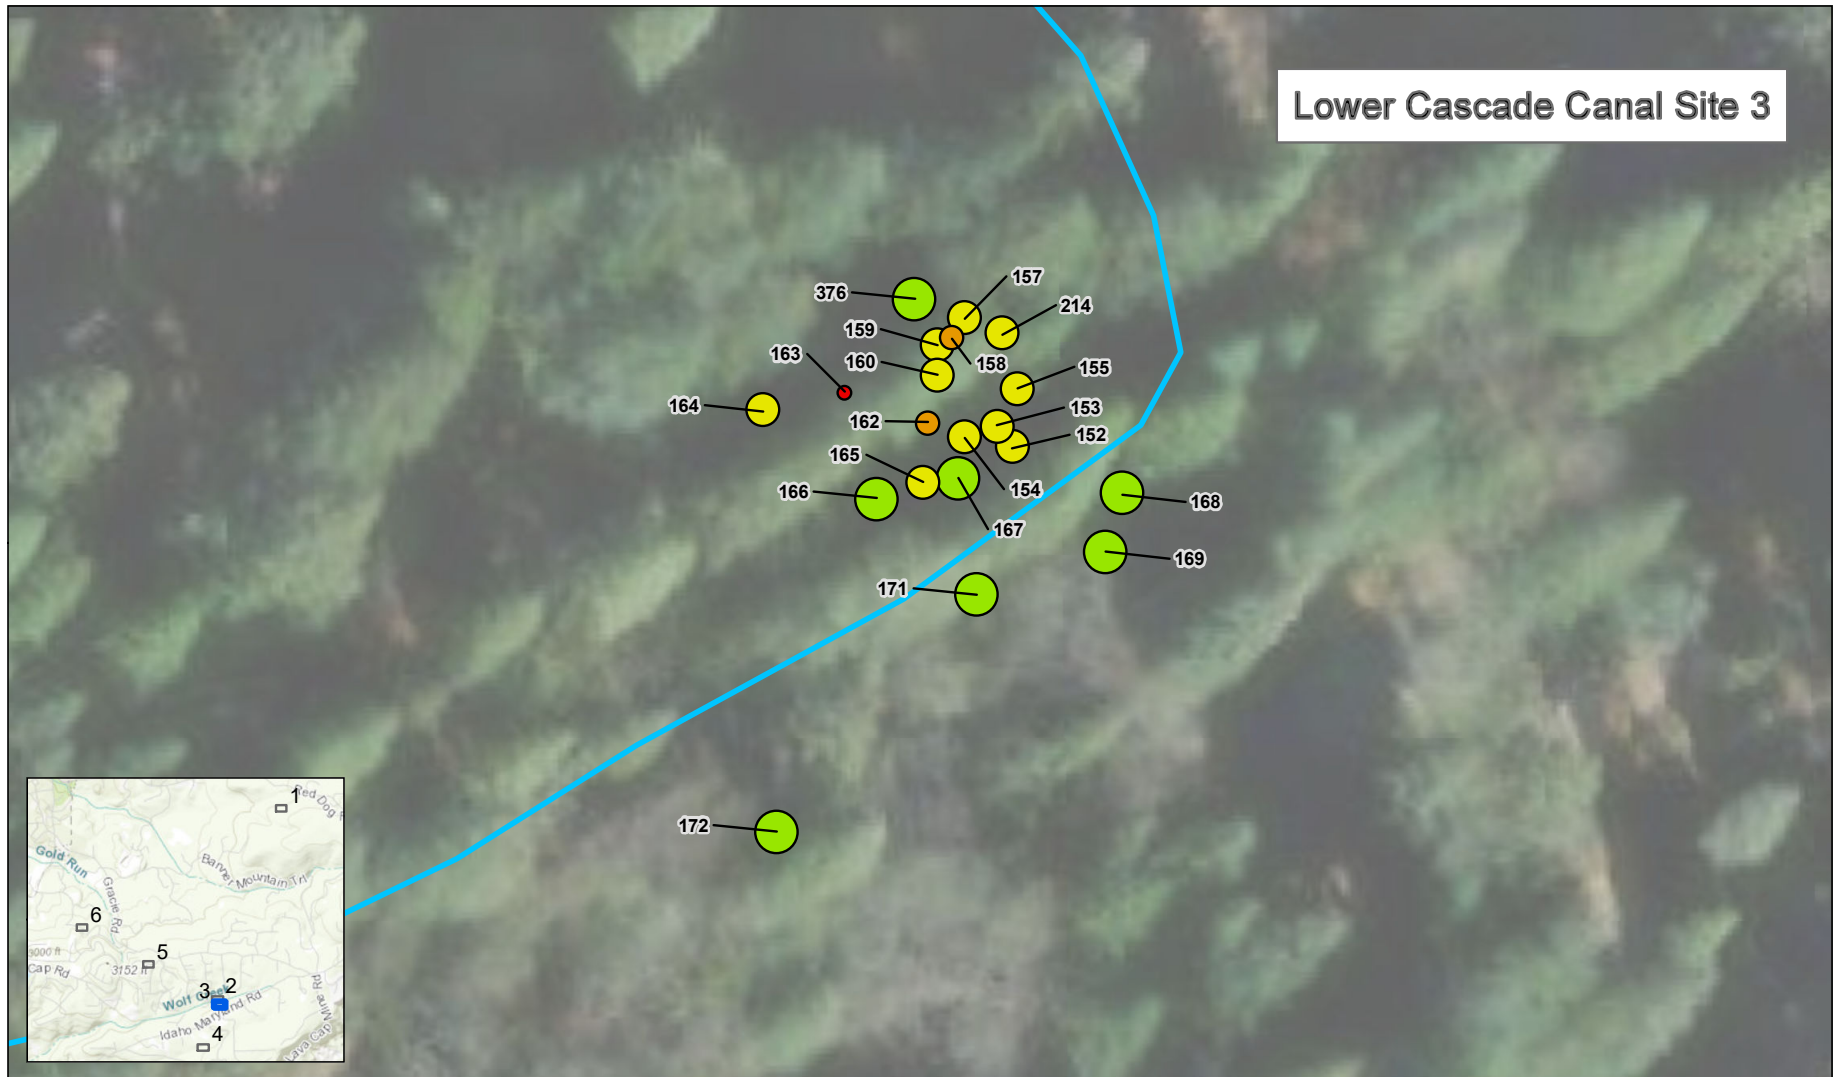
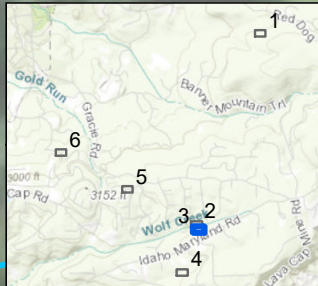
Lower Cascade Canal Site 3

During Monitoring Year 10, 20 riparian trees were surveyed at Site 3 on the LCC on October 12, 2023. Tree species surveyed include bigleaf maple, gray alder, and Pacific dogwood. No new trees were found dead. Most trees surveyed had full to partial canopy cover and good bark health. Trees exhibited some surface growth, in the presence of and insect damage and infestation. The trees exhibited new growth. Disease amongst some of the trees was observed at this site, in addition to presence of parasites. Additionally, California wild grape and English ivy were present on several tree trunks and branches. Some abnormal leaf color was observed. Overall tree health at Site 3 was good, with a range of health scores from 4 to 14 and an average health score of 10 (Table 4-3, Graph 4-3).

General site conditions included encroachment by non-native and invasive understory species that also were vining up the tree trunks (e.g., English ivy). Various upland tree species are also present at Site 3, including Douglas-fir and incense cedar.

consistently prevalent, although slightly decreased in Monitoring Year 8 and stayed consistent in Year 10. No tree deaths were observed at Site 3 since Baseline Year 0. In comparison with Monitoring Year 8, trees surveyed in Monitoring Year 10 exhibited a reduction in parasites. The trees surveyed exhibited less growth in DBH and a greater presence of abnormal leaf color and insect damage. There was consistence between new growth, surface growth, and disease between Monitoring Year 8 and Monitoring Year 10. Overall tree health at Site 3 remained consistently good in Monitoring Year 10 (Table 4-3, Graph 4-3).

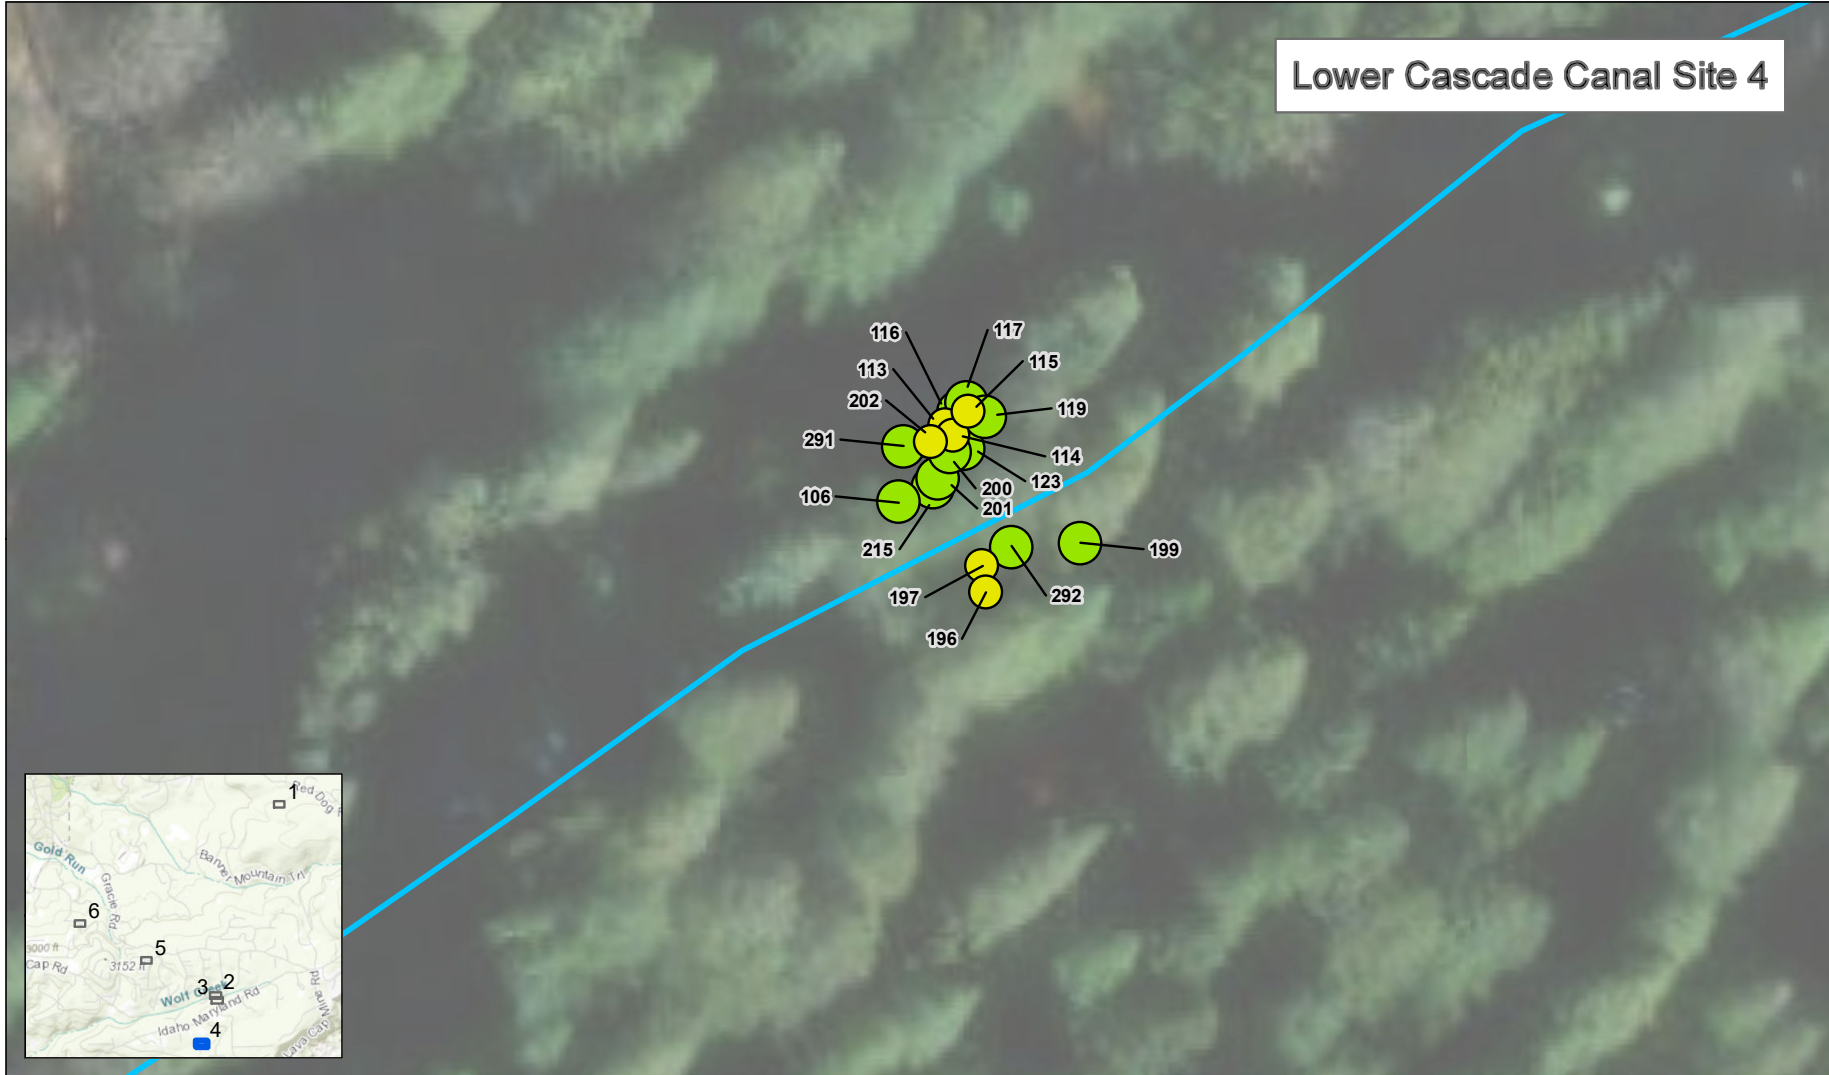
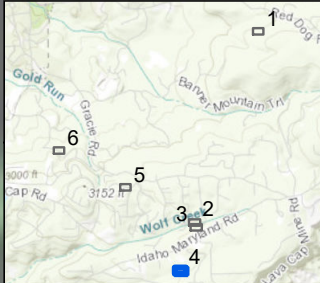
Lower Cascade Canal Site 4

General site conditions included beaked hazelnut, thimbleberry (*Rubus parviflorus*), and poison oak. Various upland tree species are also present at Site 4, including black oak, Douglas-fir, incense cedar, and tanoak.

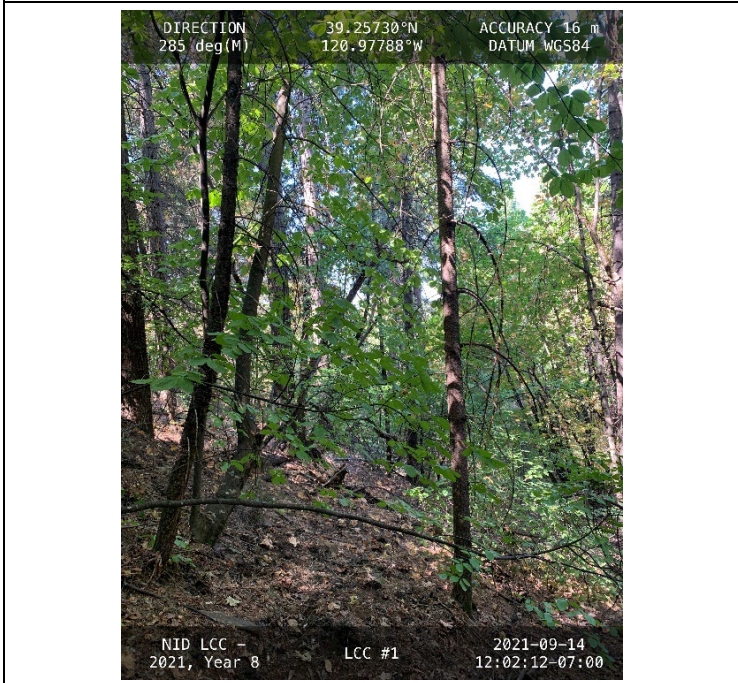
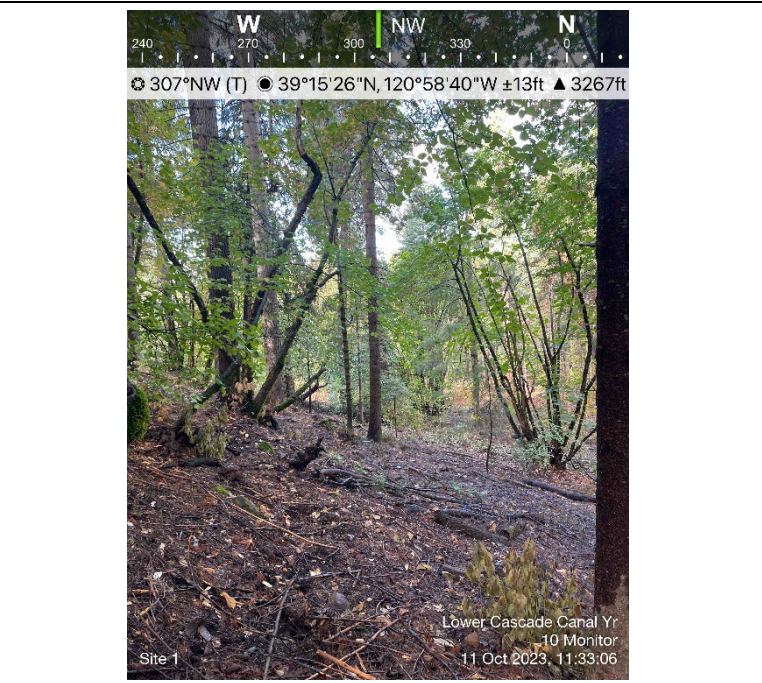
Photograph 5: 2021: LCC Site 1. Downslope location.

Photograph 6: 2023: LCC Site 1. Downslope location.

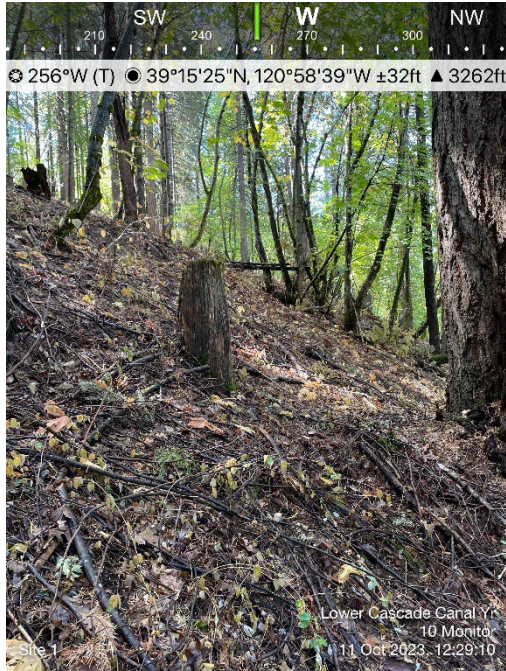
Photograph 7: 2023: LCC Site 1. Upslope location.

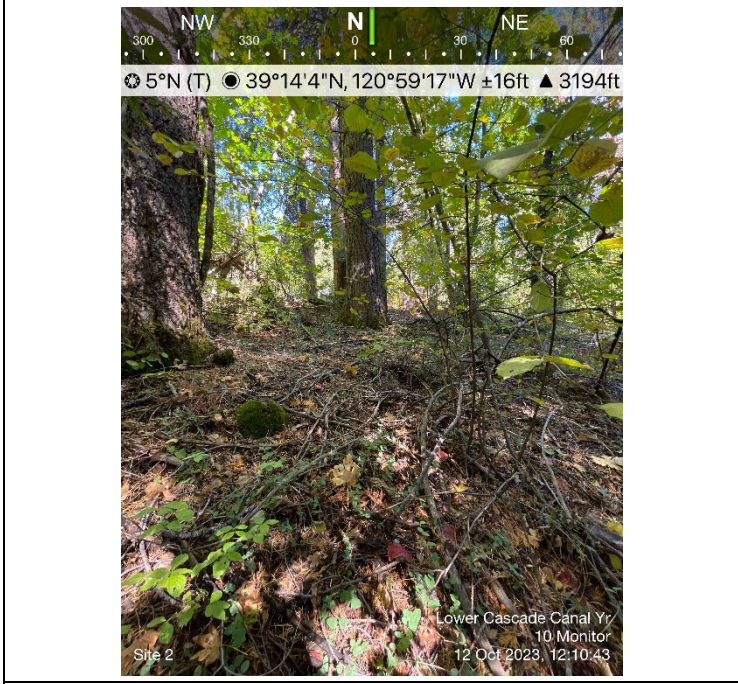
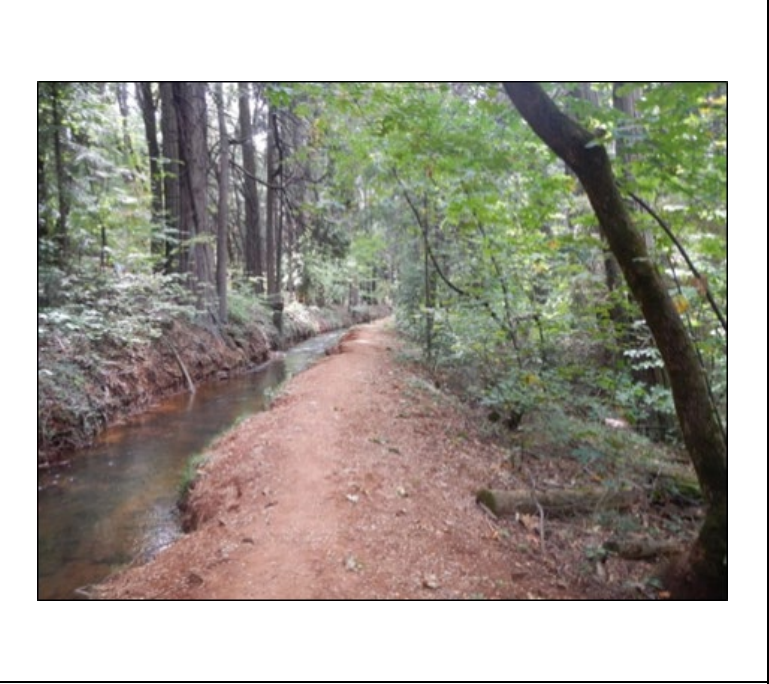
Photograph 13: 2023: LCC Site 2. Downslope location.

Photograph 14: 2013: LCC Site 3. East facing aspect.

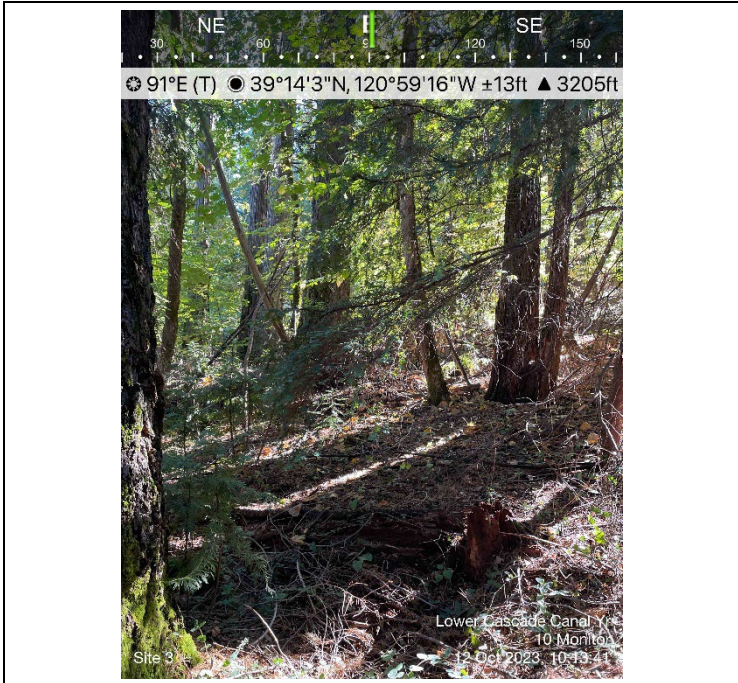
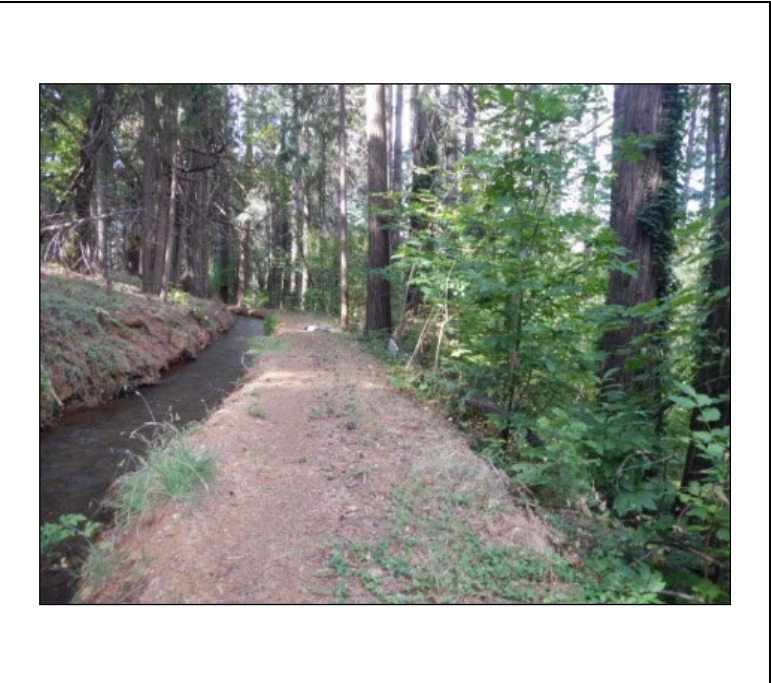
Photograph 19: 2023: LCC Site 3. Downslope location.

Photograph 20: 2013. LCC Site 4. Southwest facing aspect.

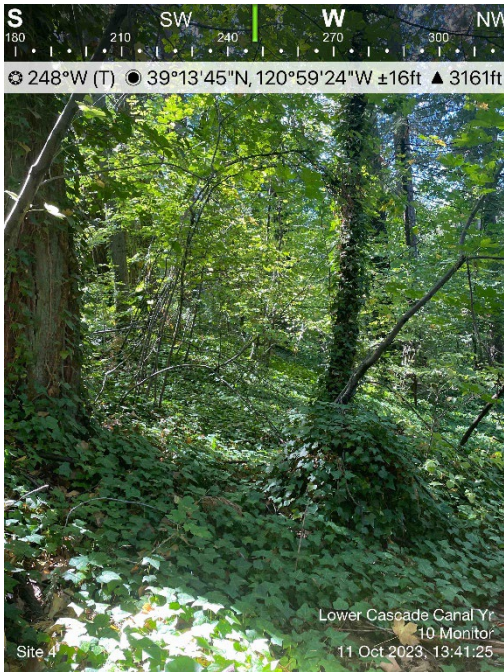
Photograph 25: 2023. LCC Site 4. Downslope location.

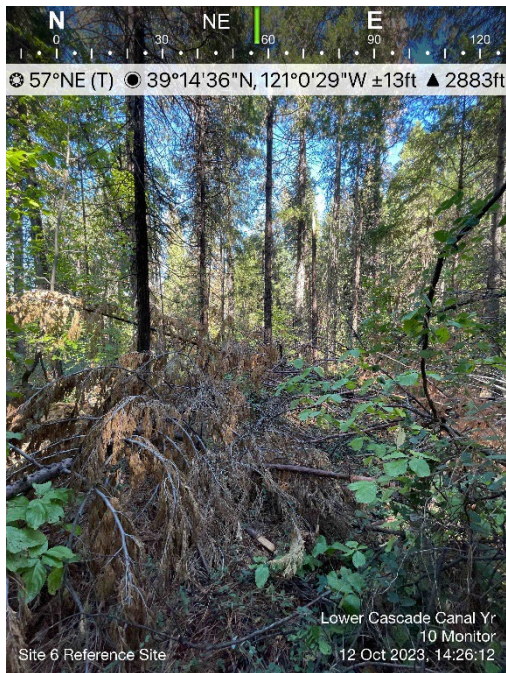
Photograph 37: 2023. DS Canal Site 6 (reference site). A lot of downed trees from February 2023 winter storm.

Project Lower Cascades Canal Site # 6-D5 Canal Reference sft
 Client NID Date 10/12/2023
 Weather Clear, sunny, warm, low 70s. Observer(s) Meghan Oats, Danny Shimmon
 Site Conditions sft significantly impacted by recent deadfall. Dense mixed conifers -
 Notes deciduous. ^{by} grow fall (Feb 2023 - lots of downed trees)

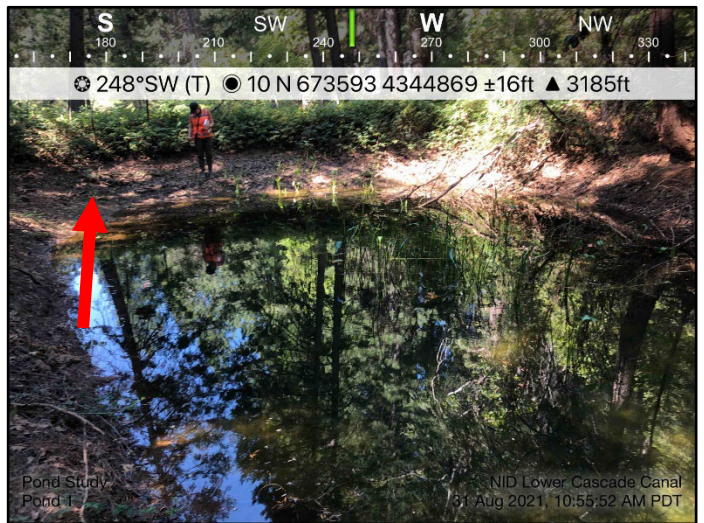
Photograph 58: 2021: LCC Pond 1. Southwest facing aspect. Red arrow indicates the location of the 6-inch culvert connecting Pond 1 and Pond 2 during higher water levels.

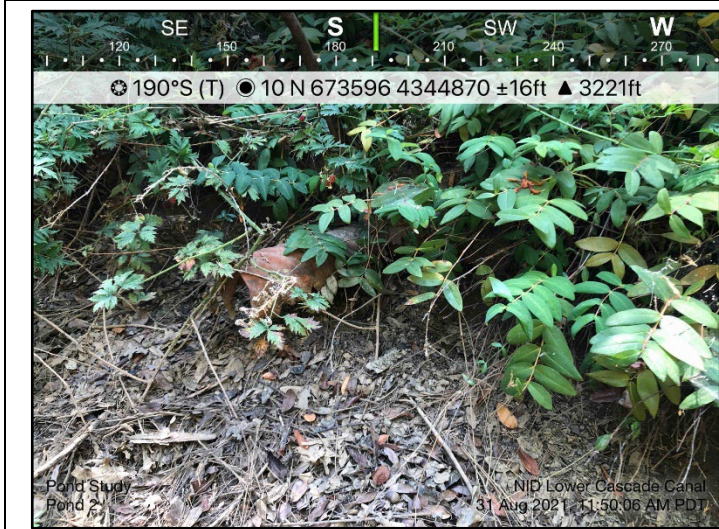
Photograph 59: 2021: Culvert between LCC Pond 1 and Pond 2. Photo taken from the Pond 1 side located in the southern corner of Pond 1.

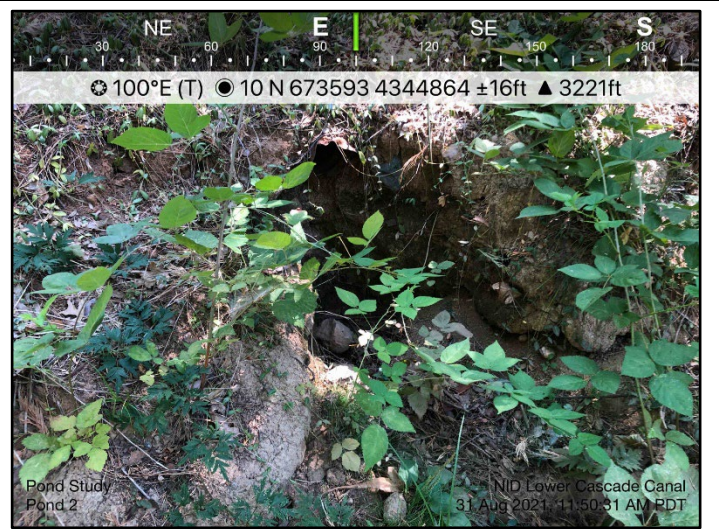
Photograph 60: 2021: Culvert between LCC Pond 1 and Pond 2. Photo taken from the Pond 2 side located in the northern corner of Pond 2.

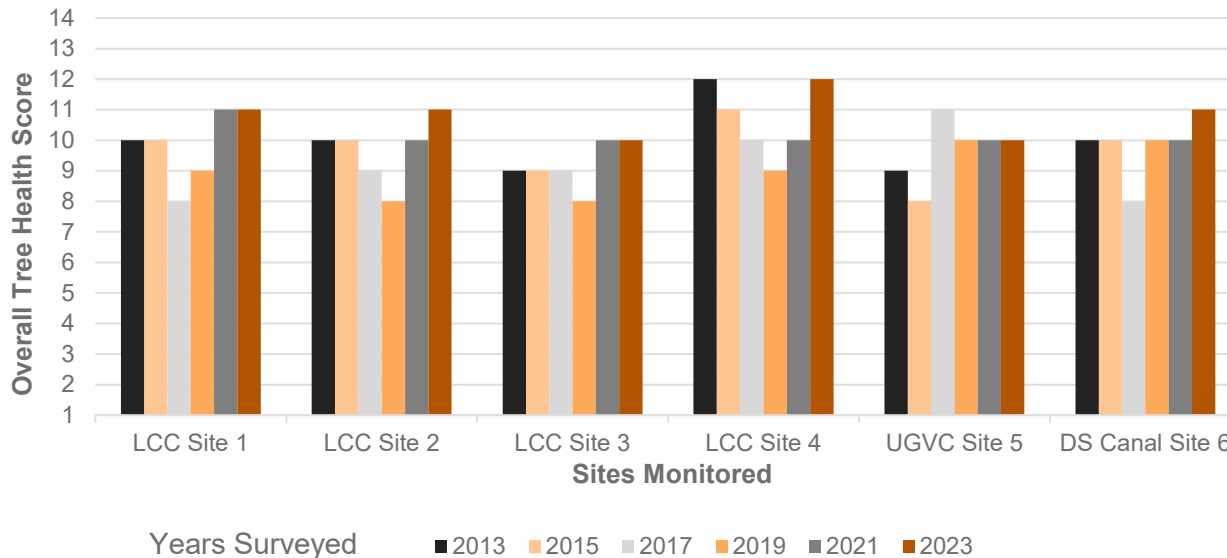
Overall Tree Health scores

- Tree health score remains above 10 at all sites = “good health” or above
- Temporal year over year variation noted. In 2023, tree health improved (had a higher score) at two LCC sites and the DS Canal (reference site), while the site along the UGVC remained consistent with previous years’ results.
- Contributing Factors
 - Increases noted in new growth
 - Overall decrease of insect infestation
 - Disease and parasites limited

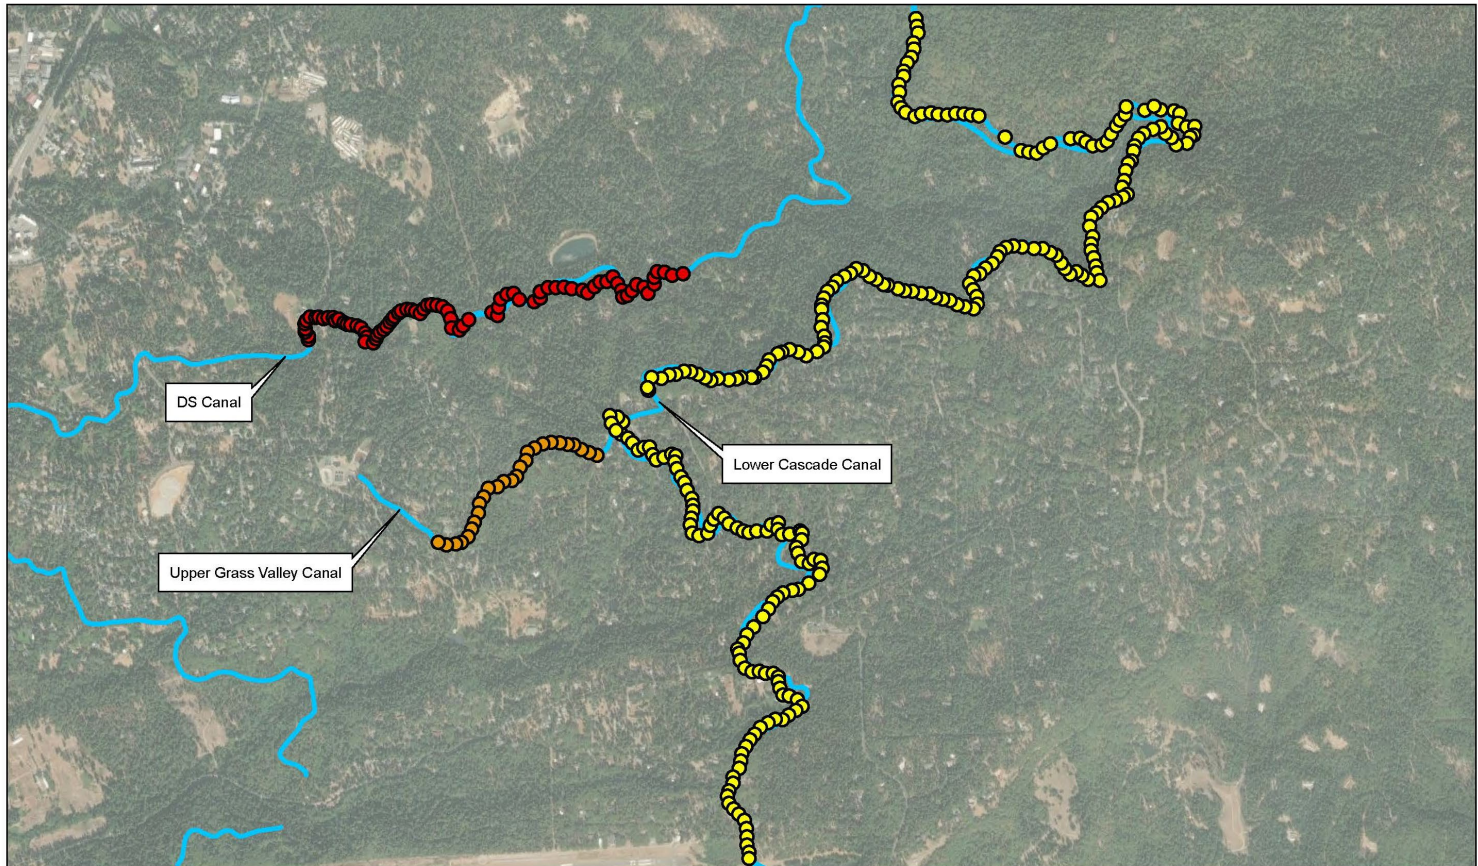
Monitoring Year 10 (2023) Canopy Cover Assessment data was collected on October 16–19 for each assessment reach. Data collection and canopy density percentages were calculated based on methods and formulas for calculating the density of the canopy described in the *Use of the Densiometer to Estimate Density of Forest Canopy on Permanent Sample Plots* (Strickler 1959). The following results average and summarize the overall canopy cover data densiometer readings collected on each canal reach during Monitoring Year 10 monitoring. Baseline Year 0, Monitoring Year 4, and Monitoring Year 8 have also been provided. A compiled data summary of Canopy Cover Assessment metrics has been provided below in Table 4.7. The locations of the observation points can be referenced in Figure 3.

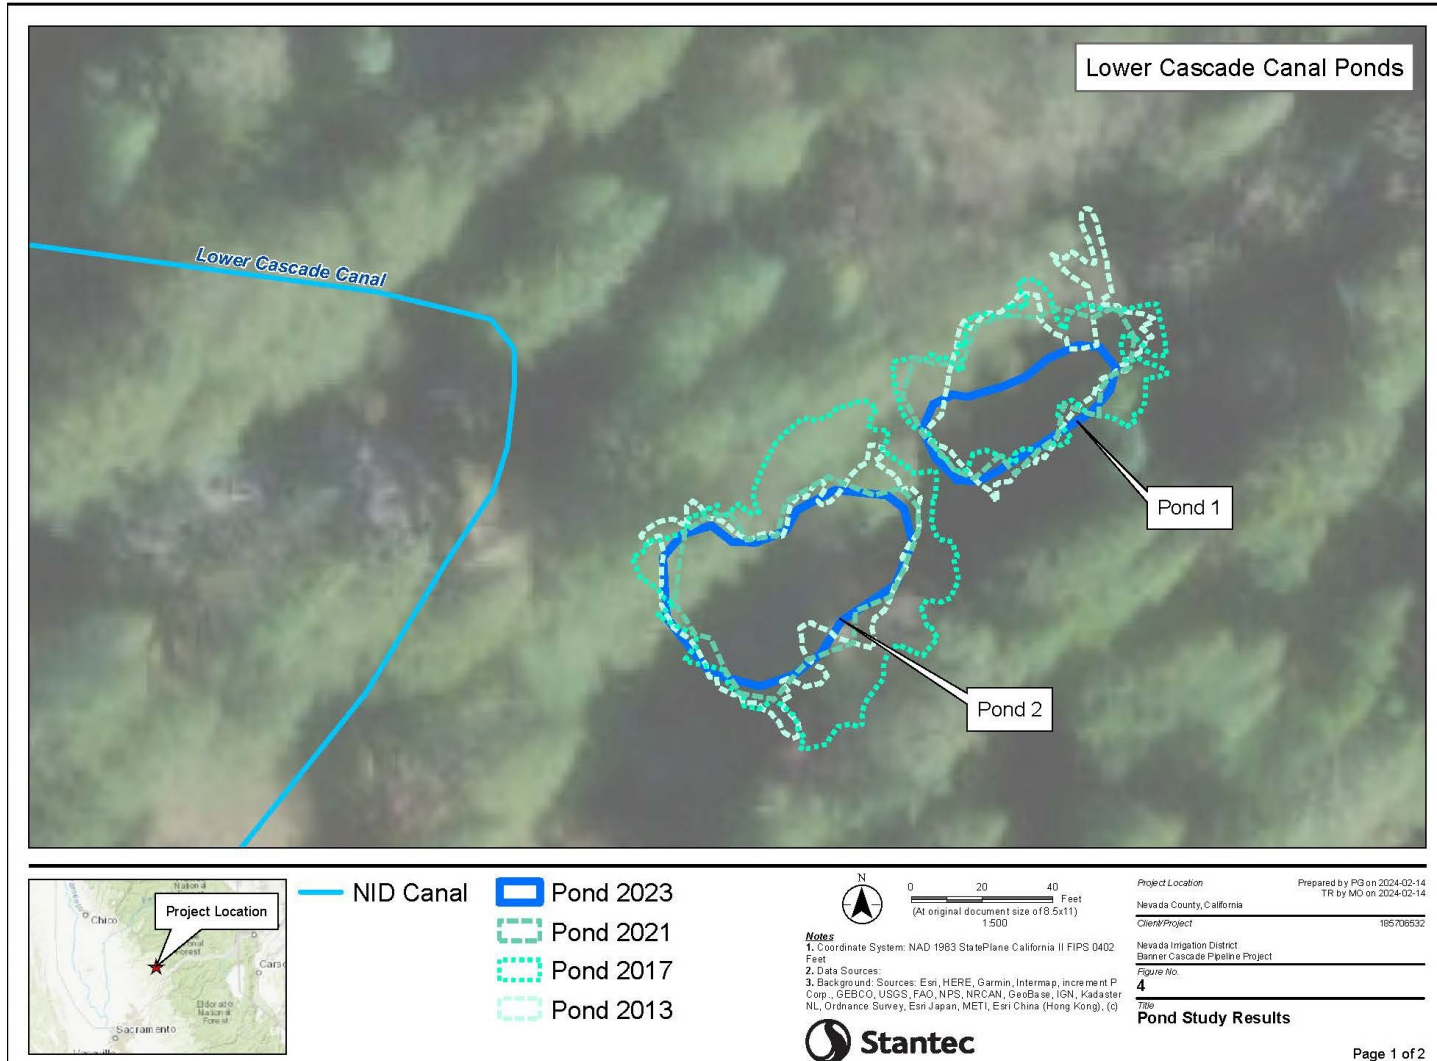
Pond Study – LCC Sites

Data for the Pond Study was collected on Tuesday, September 6, 2023 at the three Pond Study sites adjacent to the LCC (Pond 1 and Pond 2) and DS Canal (Pond 3). As stated in the methods section above, no data was collected along the UGVC because no ponds were identified during the initial development of the study. During the field assessment, the parameters evaluated included the area of inundation and soil saturation, approximate water depth(s), apparent hydrology patterns, soil type(s) present, vegetation communities present, wildlife species present, and habitat for CRLF. Table 4.8 summarizes the Pond Study results for metrics collected during surveys conducted in 2013, 2017, 2021, and 2023 (Year 0, Year 4, Year 8, and Year 10). Figure 4 includes maps of LCC Ponds 1 and 2 and the DS Canal reference site, Pond 3.
