# HEMPHILL DIVERSION STRUCTURE AND FISH PASSAGE ASSESSMENT

## FINAL REPORT

**Nevada Irrigation District**  
Grass Valley, California

**Northwest Hydraulic Consultants Inc.**  
Sacramento, California

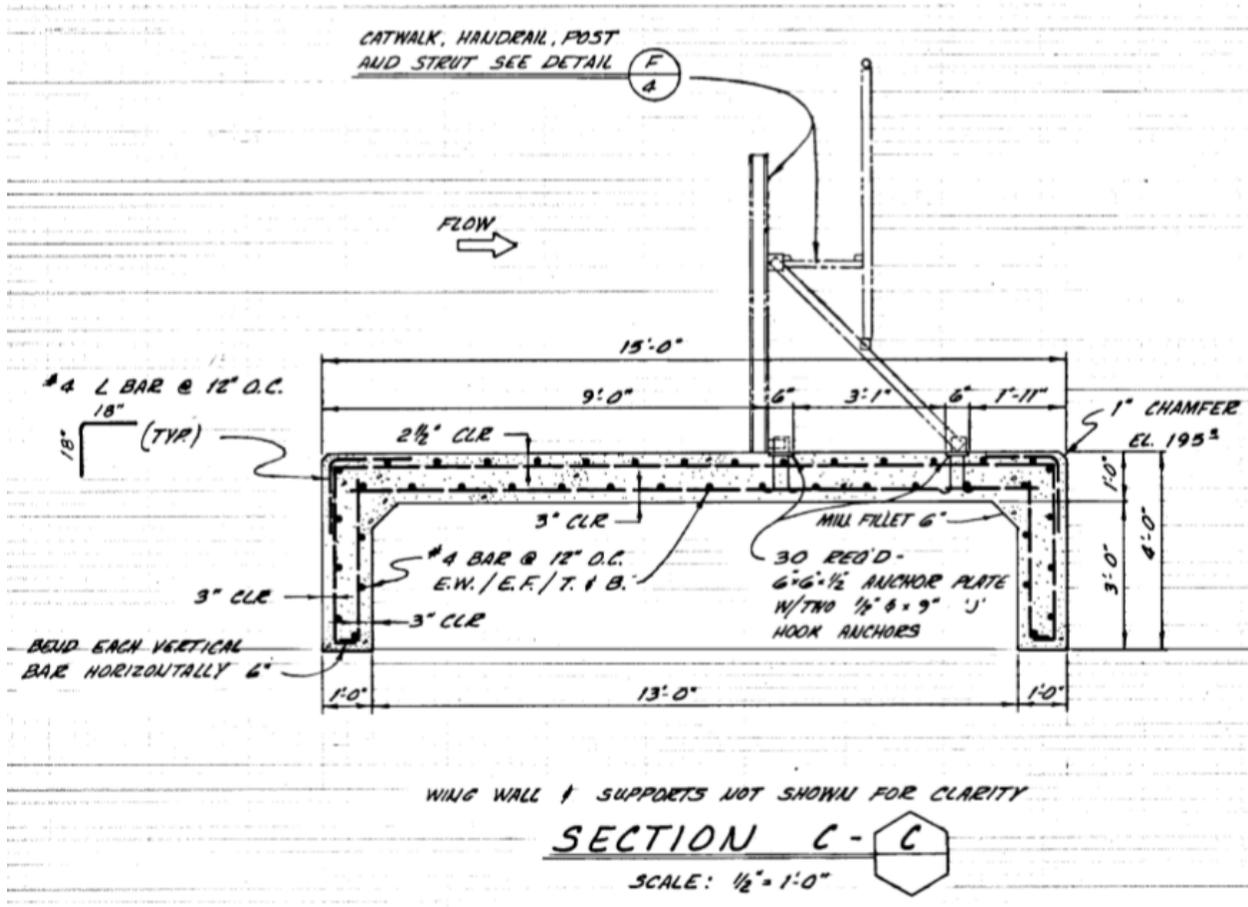
Figure 1-1. 1981 as-built cross section of existing dam. Figure source: NID's 1981 as-builts.

The Hemphill diversion dam, constructed in 1981, is a 64-foot-wide channel-spanning concrete structure in Auburn Ravine. The dam's concrete crest has an elevation of 197.4 ft (NAVD88). Seasonal wooden flashboards raise the dam's crest three feet up to an elevation of 200.4 ft during the summer diversion season from about April 15<sup>th</sup> through October 15<sup>th</sup>. Given the depth of the original dam foundation (Figure 1-1), we presume the dam crest was constructed at the original channel bed elevation, prior to significant downstream incision. According to the 1981 as-built drawings, the dam was constructed with 6-foot-tall wing walls on both banks, and did not include any bank fortification upstream or downstream of the dam. Bank fortification was added later after three large flood events in 1997, 2006, and 2017 (see section 1.2.2) severely eroded the banks and dam foundation. Due to ongoing channel incision downstream, the concrete crest of the existing dam is approximately ten feet above the scoured channel bed immediately downstream of the dam, according to a topographic and bathymetric survey completed by NID in March 2020. In general, the wooden flashboards are in place from April 15<sup>th</sup> through October 15<sup>th</sup> during diversion season.

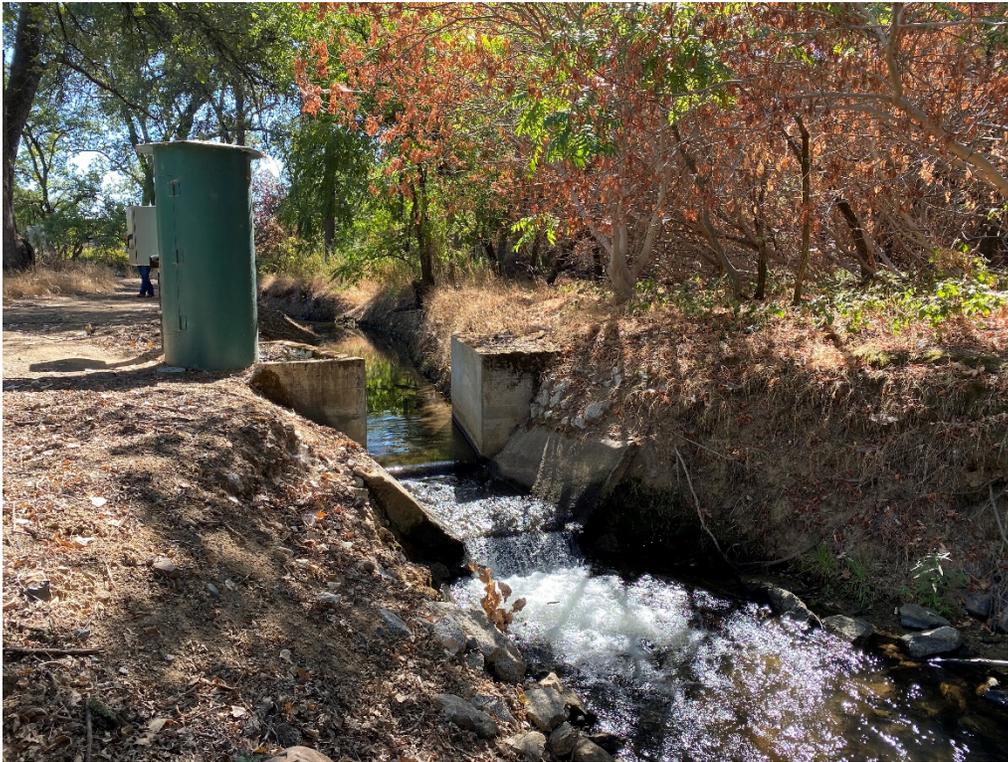
feet, the canal drops eight feet and has an average slope of 0.22%. Flow in the canal is provided during irrigation season when NID installs wooden flashboards along the crest of the dam, providing three feet of head to drive the diversion flow. Flow within the canal is then regulated with a slide gate at its intake; however, the canal is unscreened and does not exclude fish from entering the canal. There are several structures within the canal such as a culvert at the canal's entrance, a gaging station (Figure 2-4), several culverts that flow underneath the Turkey Creek Golf Club, and at least one check station before the first point of use. During a brief field visit in September 2020, we noticed that there was a significant hydraulic drop downstream of the Parshall flume gaging station, which can be seen in Figure 2-4, indicating that there is room to improve the canal's hydraulic efficiency, such as regrading a portion of the canal, lining the canal with smooth concrete, or piping a portion of the canal (discussed in Alternative 2).

**Figure 2-4. Gaging station and Parshall flume within the Hemphill Diversion. Photo source: NHC**

between the entrance and point of first use, which is reasonable and typical for an irrigation canal of this size. As shown in Figure 2-4, taking advantage of hydraulic inefficiencies, such as the drop downstream of the Parshall Flume, can partially make up for the effects of reprofiling a portion of the canal. Additionally, a portion of the canal can be piped with smooth-walled HDPE pipe or lined with smooth concrete to further improve hydraulic efficiency. We recommend completing a detailed topographic survey of the canal and performing a subsequent hydraulic analysis of its flow characteristics in order to determine the extents and parameters for regrading the canal.

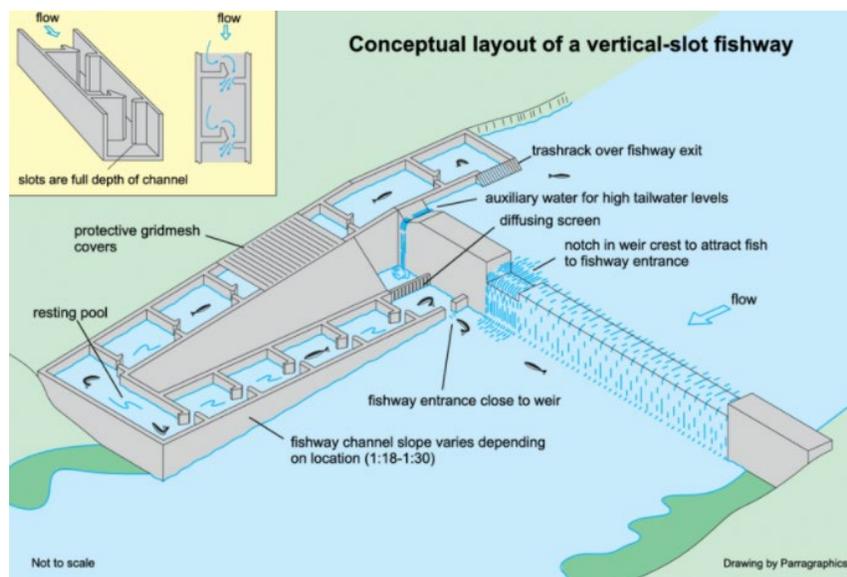
A vertical slot fishway is a traditional, technical fishway (Figure 3-4). It is constructed in a rectangular concrete channel with a downstream sloping floor, and is divided into a number of pools. Each pool is separated by concrete partition with a vertical slot extending to the floor. As water passes downstream through the fishway, fish are able to migrate upstream through the vertical slots. In vertical slot fishways, the water level is self-adjusting based on the flow rate through the structure allowing it to function both with and without flashboards installed on top of the existing dam.

**Figure 3-4. Schematic diagram of a vertical slot fishway bypassing a dam. Note that the fishway entrance is as far upstream as possible, which is preferable for migrating salmonids. Figure credit: Thorncraft & Harris, 2000**

This alternative assumes the existing dam is left in place. The vertical slot fishway could be installed to bypass around the existing dam, and would be inset within the bank. This type of structure would not alter the existing dam structure, which would avoid further compromising it. Off-channel bypass fishways are generally less-susceptible to becoming clogged with debris since they are not in the main course of the river. This option could work on either the north or the south bank; however, NID

expressed preference for the north bank for ease of access and maintenance. The vertical slot fishway would be constructed close to the dam within the scour pool immediately downstream, which is approximately 13 feet lower than the top of the flashboards during diversion season. This structure would not be able to tie into the existing hydraulic control approximately 170 feet downstream. For a slot width of one-foot (typical for salmonids), and an elevation gain of 13 feet, the overall migration pathway length would be approximately 130 feet long (Rajaratnam, Katopodis, & Solanki, 1992); however, as Figure 3-4 shows, a turning/resting pool would allow for the fishway footprint to be much shorter, instead of having a continuous linear 130-foot long structure. Vertical slot fishways are typically suitable for fish species with strong swimming abilities, such as salmonids. Weaker fish, such as lamprey, often have a harder time overcoming the fast through each of the vertical slots. However, some modifications, such as rounded corners, can be made to make the vertical slots more suitable for Pacific Lamprey to provide a continuous attachment point (Figure 3-5).

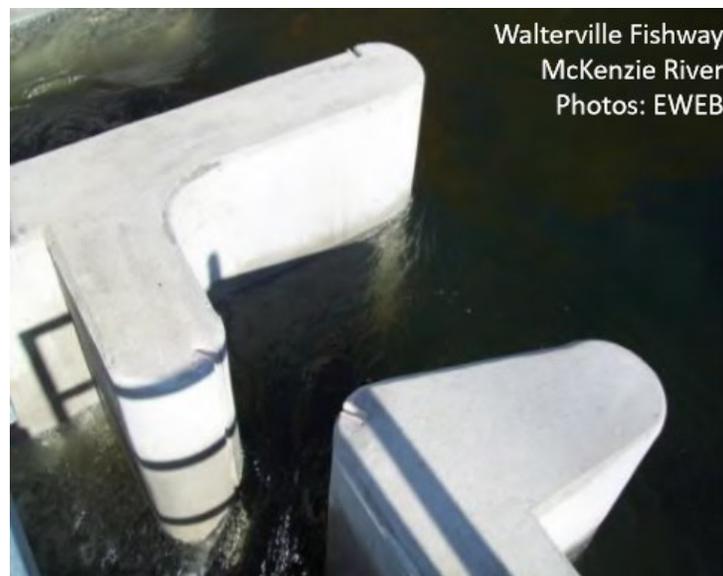
**Figure 3-5. An example of a vertical slot fishway with rounded corners for Pacific Lamprey passage. Lamprey passage is improved in fishways when concrete corners are rounded with a 3-4 inch radius. Photo credit: Eugene Water and Electric Board**

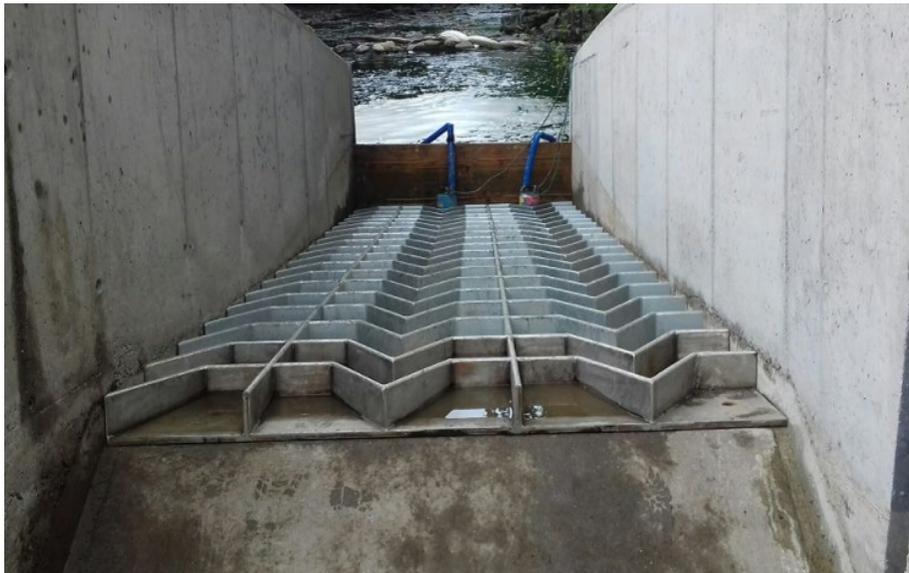
Alternative 4 entails installing a Larinier fishway. Larinier fishways are modified Denil fishways (Larinier, Travade, & Porcher, 2002; Armstrong, et al., 2010), and are typically designed for passing salmonids and sea trout in the United Kingdom. They are constructed with vertical walls – generally from concrete – and have steel herringbone baffles on the bottom. They also tend to have strong attraction flows. Given similar species characteristics with Chinook salmon and steelhead, this structure may be compatible with NID’s project objectives while also meeting fish passage requirements for salmonids. Larinier fishways can be constructed at a steep slope, up to approximately 15%, which reduces its overall footprint. We propose two Larinier fishway alternatives: 1) installing a Larinier fishway as a bypass around the dam, and 2) installing a seasonal, modular Larinier fishway over the existing dam.

**Figure 3-6. Larinier fishway looking downstream. Note the vertical, smooth side walls, and the wide, baffled base. Photo credit: Aquatic Control Engineering**

For the bypass Larinier fishway, we recommend a two-stage Larinier designed to bypass around the dam. Like the vertical slot fishway alternative, this alternative also assumes that flashboards will be installed across the dam crest during diversion season, thereby raising the upstream water surface elevation by three feet for portions of the year. As such, we recommend designed a two-stage fishway. A two-stage fishway allows the structure to be operational year-round. During non-diversion season (when flashboards are not installed along the dam crest), the lower stage of the fishway exit would be open. During diversion season (when flashboards are installed), the upper stage of the fishway exit would be open. A bypass Larinier fishway would be approximately 90 feet long at a 15% slope to account for 13 feet head drop during irrigation season (assuming three feet of flashboards are installed across the dam crest). The fishway could be installed on the north or south bank; however, based on comments from NID, the north (right) bank would be easier to access for maintenance. Because Larinier fishways can be designed as rather wide channels (their overall width can be highly variable), they are also generally less susceptible to debris entrainment, which would lower maintenance frequency. Additionally, inseting the Larinier structure within the bank would increase the susceptibility of flanking the dam during large flood events. To minimize flanking, we recommend heavily fortifying the banks surrounding the structure with grouted boulders or gabion baskets.

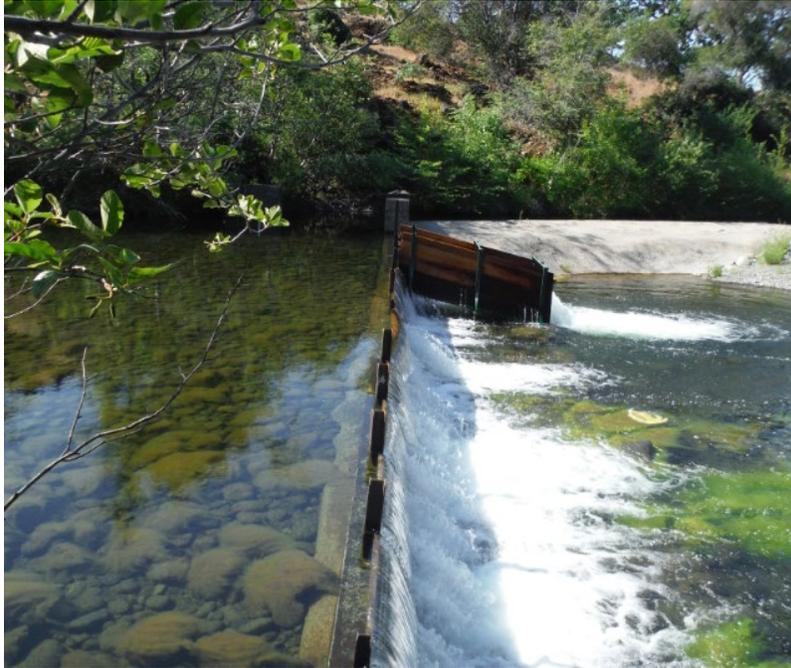
**Figure 3-7. Example of a removable fishway structure on a diversion dam installed during diversion season (while flashboards are currently installed). Photo credit: NHC**

A removable, modular, in-stream Larinier fishway could potentially be installed on the existing dam. This would be a relatively low-cost option (compared to other alternatives in this report); however, not without possible complications. Given that the existing dam's foundation is highly compromised, we recommend a thorough structural analysis of the dam before pursuing this option. We do not recommend this option if the added weight of the Larinier structure will further compromise the dam. This temporary Larinier structure would be approximately 75-90 feet long at a variable 11-15% slope. The structure would be modular (to install and remove in pieces, rather than as an entire structure). During non-irrigation season, the Larinier structure would be flush with the existing dam crest. During irrigation season, the upstream side of the structure would be raised to account for the addition of flashboards across the dam. The downstream pivot point would remain the same. This option could provide year-round fish passage provided that the upstream portion of the fishway is raised and lowered depending on whether the flashboards are installed. Figure 3-7 shows an example of a temporary, removable fishway, installed during diversion season.

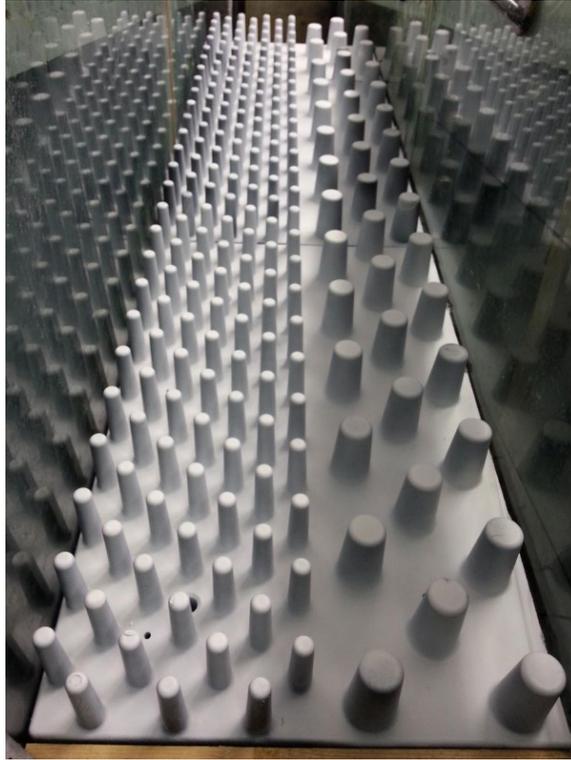
**Figure 3-8. An example of studded tiles designed for lamprey passage. Photo credit: University of Southampton**

While Larinier fishways are suitable for strong swimmers, such as adult salmon and steelhead, they are not as compatible for weaker swimmers such as lamprey. If Pacific Lamprey are identified as a target species, we recommend installing a studded tile fishway adjacent to the Larinier fishway (Figure 3-8). Similar to Larinier fishways, studded tile fishways have smooth, vertical walls; however, instead of metal herringbone plates, they have studded plastic plates along the bottom of the fishway. The studded plates are designed to be compatible with lamprey morphology by providing the lamprey with a continuous smooth attachment surface, while the studs provide energy dissipation (Lothian, Tummers, A, O'Brien, & Lucas, 2020; Tummers, et al., 2016).

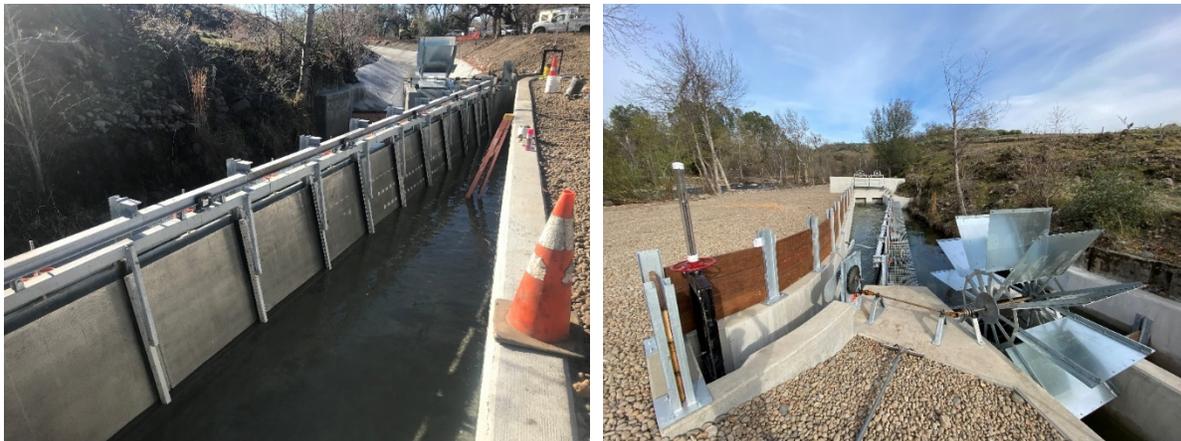
Both screen options could likely be designed to either have a water-powered or electric (assuming on-site power) brush system. Figure 3-9 shows a water-driven paddle wheel that turns as water flows into the diversion, thus driving the screen brushes shown in the left-hand photo. The brushes on the cone screen in Figure 3-10 are driven by an internal water-powered impeller. If on-site power is available, the brush cleaning systems could be fully electric reducing headloss through the facility.

Figure 3-9. Example of a flat plate screen. NHC designed and installed this screen for Deer Creek Irrigation District in Tehama County, CA in 2019.

While not part of this current scope, NHC and NID engineers briefly discussed the feasibility of incorporating a fish screen on the Hemphill Diversion entrance to exclude migratory salmonids and other native fish from entering the canal. NID expressed interest in adding a fish screen to the entrance of the existing diversion canal to exclude fish from entering the canal. Installing fish screens on the Hemphill diversion could be an alternative to existing alternatives of piping diversion flow from upstream or installing an infiltration basin and diversion pump along the bank (Kleinschmidt, 2016). Although the infiltration basin alternative would inherently provide fish screening; potential clogging of the basin by fine sediment could require costly maintenance relative to fish screens. Two fish screen options that would work with Alternatives 1 through 5 (elevations would have to be adjusted depending on alternative designed at the am) would be a flat plate screen (Figure 3-9) and a cone screen (Figure 3-10).

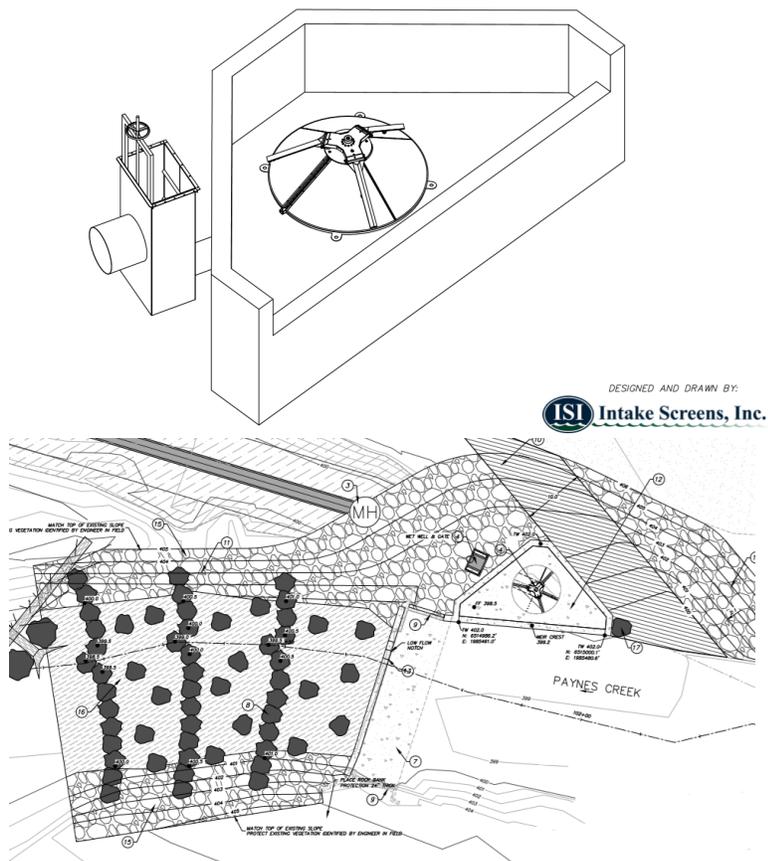
Figure 3-10. Example of a cone screen. NHC is currently designing this cone screen for Bend Water Users in Tehama County, CA
