Staff Report

SUBJECT: Workshop – Combie Dam Alternatives for Repairs and Improvements

Combie Dam is owned by the Nevada Irrigation District (NID) and located on the Bear River in the Sierra Nevada foothills in Northern California. The dam is subject to regulations through the Federal Energy Regulatory Commission (FERC) and the California Department of Water Resources, Division of Safety of Dams (DSOD). Constructed in 1928 with a central variable-radius concrete arch that incorporates a two-stage spillway (overflow section) that is abutted by concrete gravity block (non-overflow) sections, the dam has a history of foundation scour damage downstream of the spillway and is subject to overtopping of the non-overflow abutment sections for the probable maximum flood (PMF).

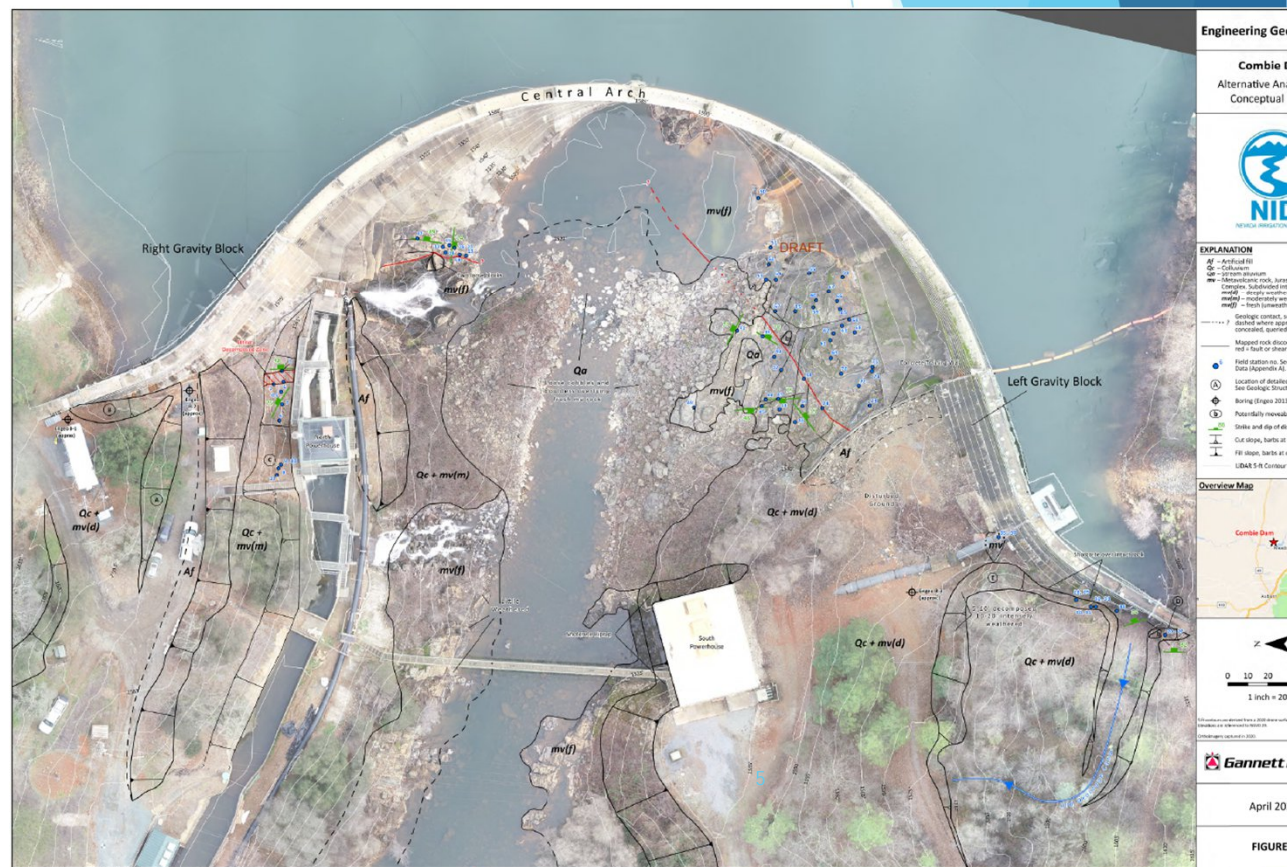
Combie Dam Spillway

- ▶ 3 center bays
- ▶ 11 total bays
- ▶ 440' long
- ▶ Significant spill events
 - ▶ 1982 - 15,400 cfs
 - ▶ 1986 - 22,500 cfs
 - ▶ 1997 - 34,000 cfs
 - ▶ 2005 - 25,800 cfs
- ▶ Capacity - 34,180 cfs
- ▶ PMF - 75,800 cfs

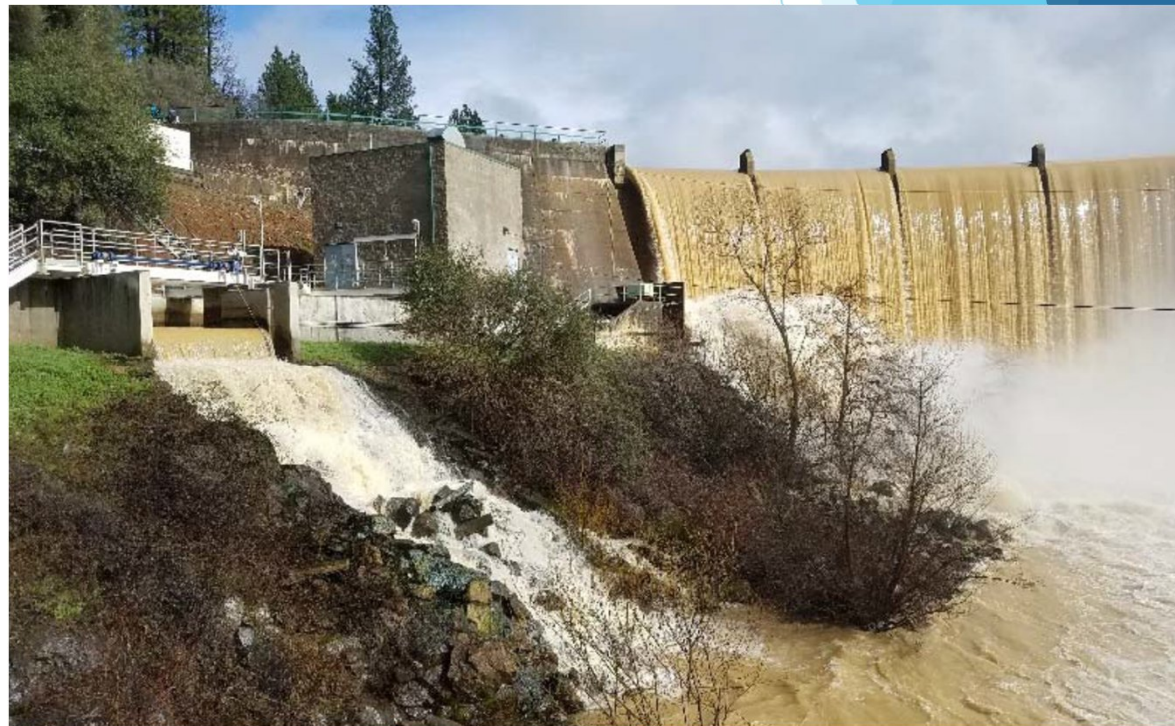
Combie Dam Scour History

- ▶ 18 of 98 year history show scour damage and repair in dam toe area
